Examples For Reliability-Critical Construction Weakness in Small-Power-Hybrides And Semiconductors

Peter Jacob 1,2), Giovanni Nicoletti 1)

Reliability Problems in Small Power Hybrides

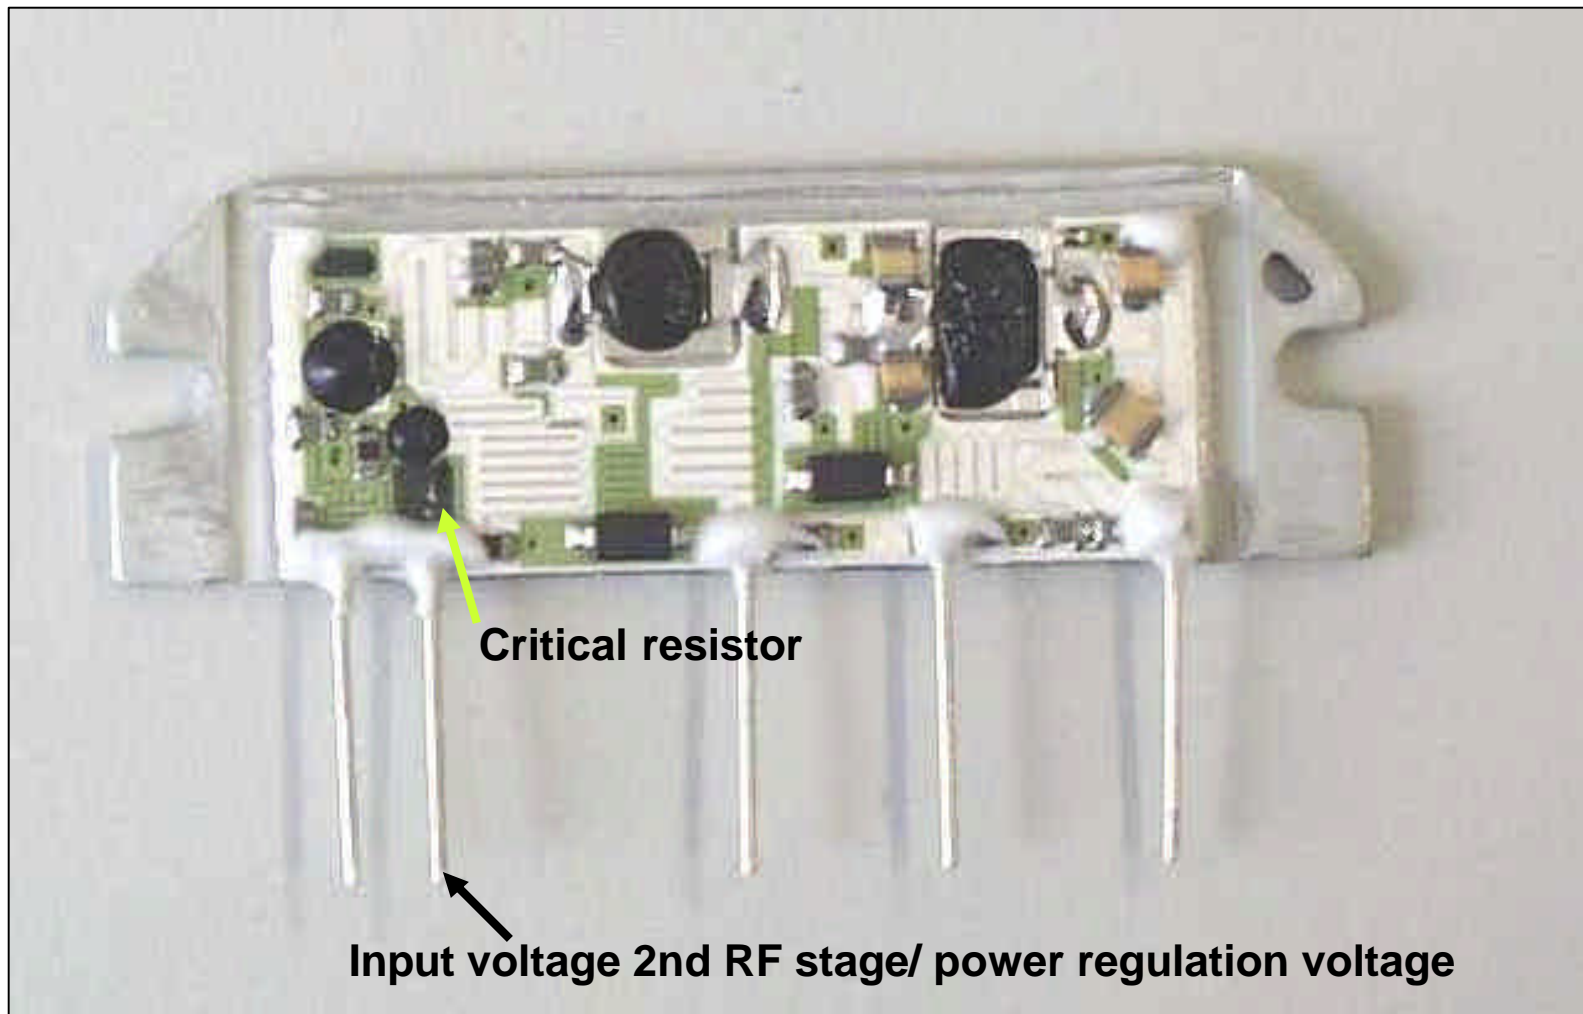
Sheet resistor, adjustment by laser trimming;

Laser cut reduces conducting gauge too much. In case of fully loaded power, current density reaches the melting point.

Consequences: In the normal case of low-power operation nothing will happen; in case of increasing the power, the resistor burns off slowly.

At first, the maximum RF output power will be reduced, later-in-time the component will fail completely (in the field)

Surface view onto the open RF hybride module

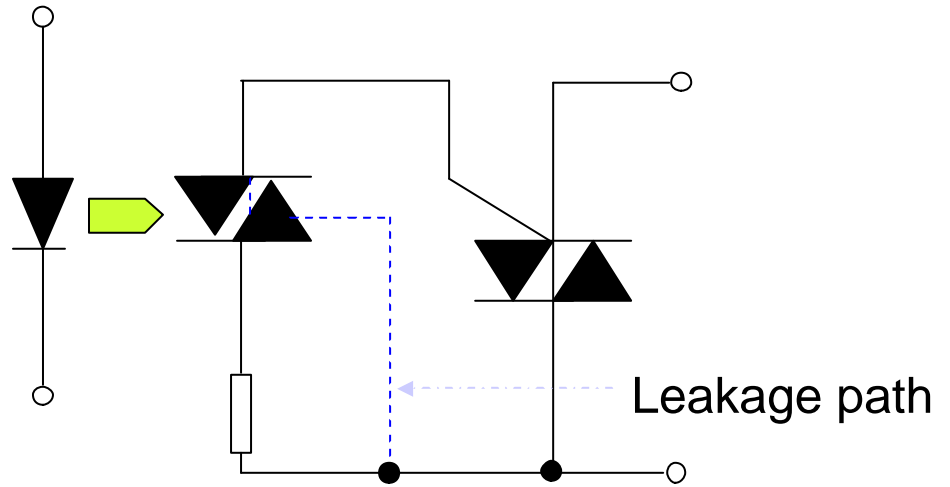
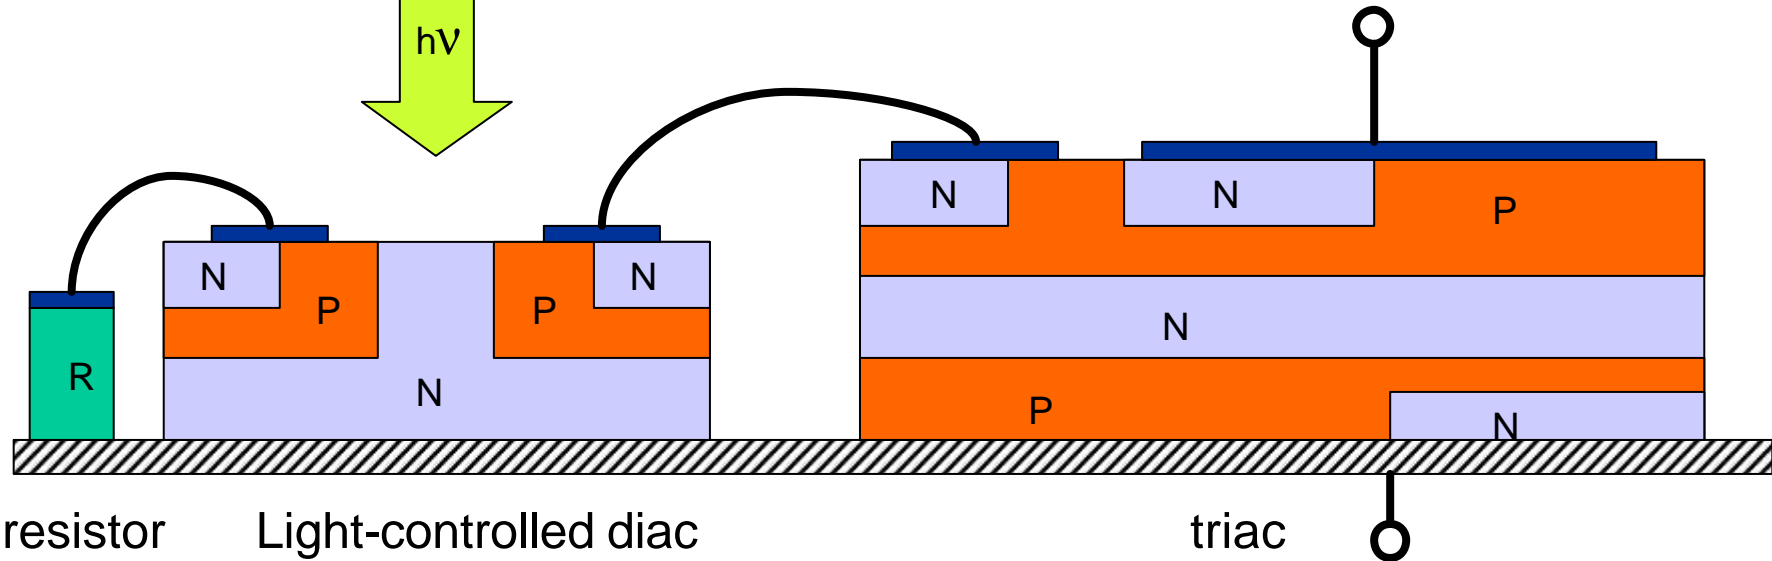
Circuitry:

A light activated diac controls the triac. Diac and triac are mounted on the same carrier plate. Thus, the Si-substrate of the control-diac is coupled galvanically to a triac-contact.

This electrical coupling reduces the voltage insulation capability of the diac-control by about 50%.

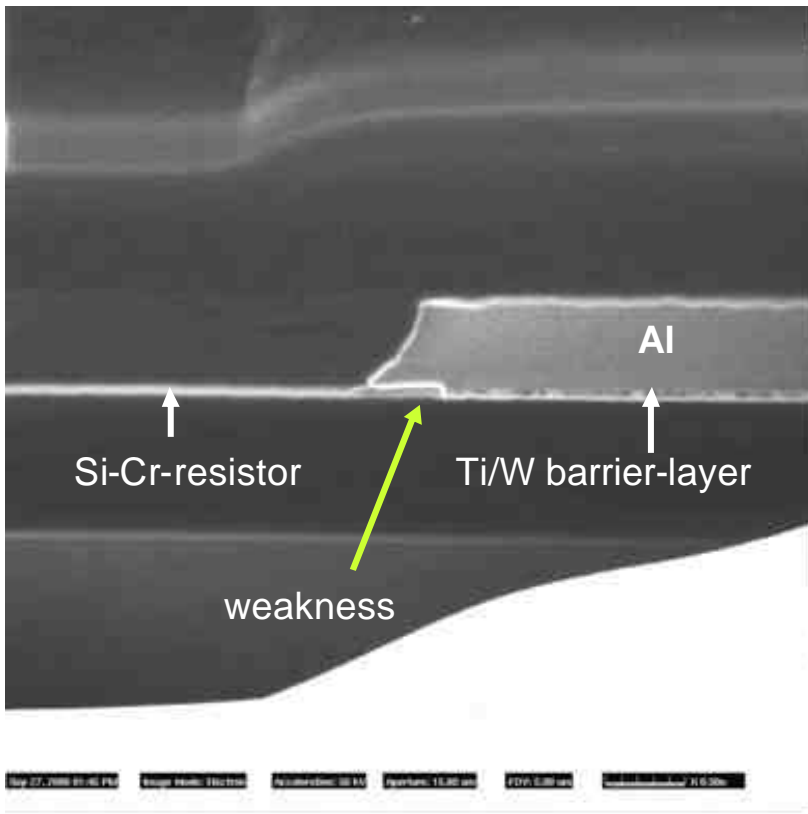
Overlapping contact of a thin-film Si-Cr-resistor to the first Al-metallization caused reliability failures

- No correct material-connecting contact; instability observed under current load
- Thermomechanical mismatch at higher loads causes interrupt opens

Weak point of the Si-Cr-sheet resistor

Original state

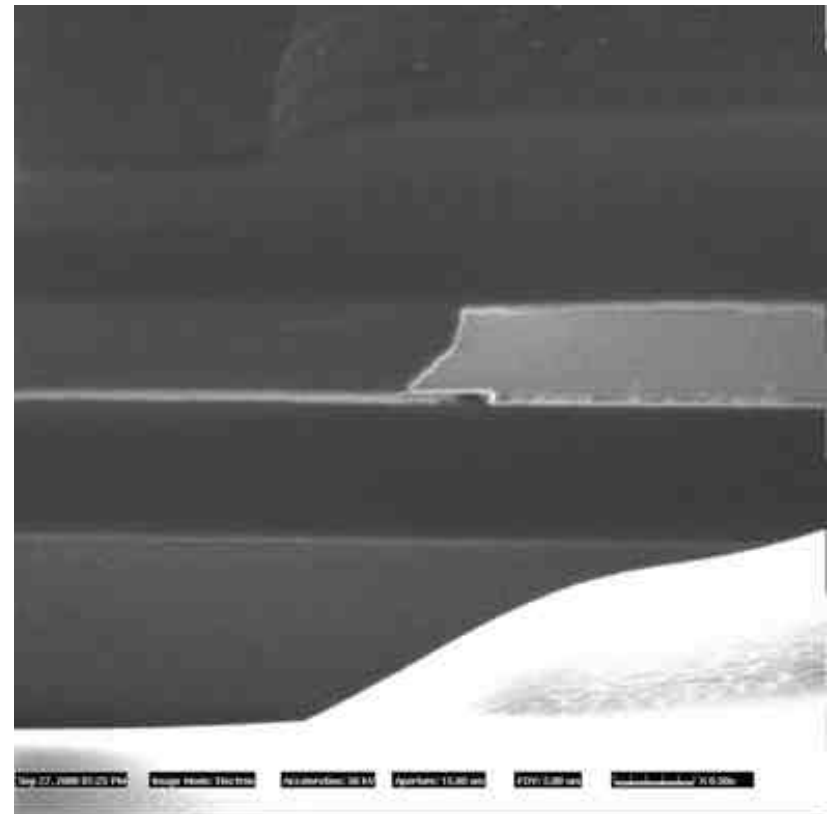
...growing damage

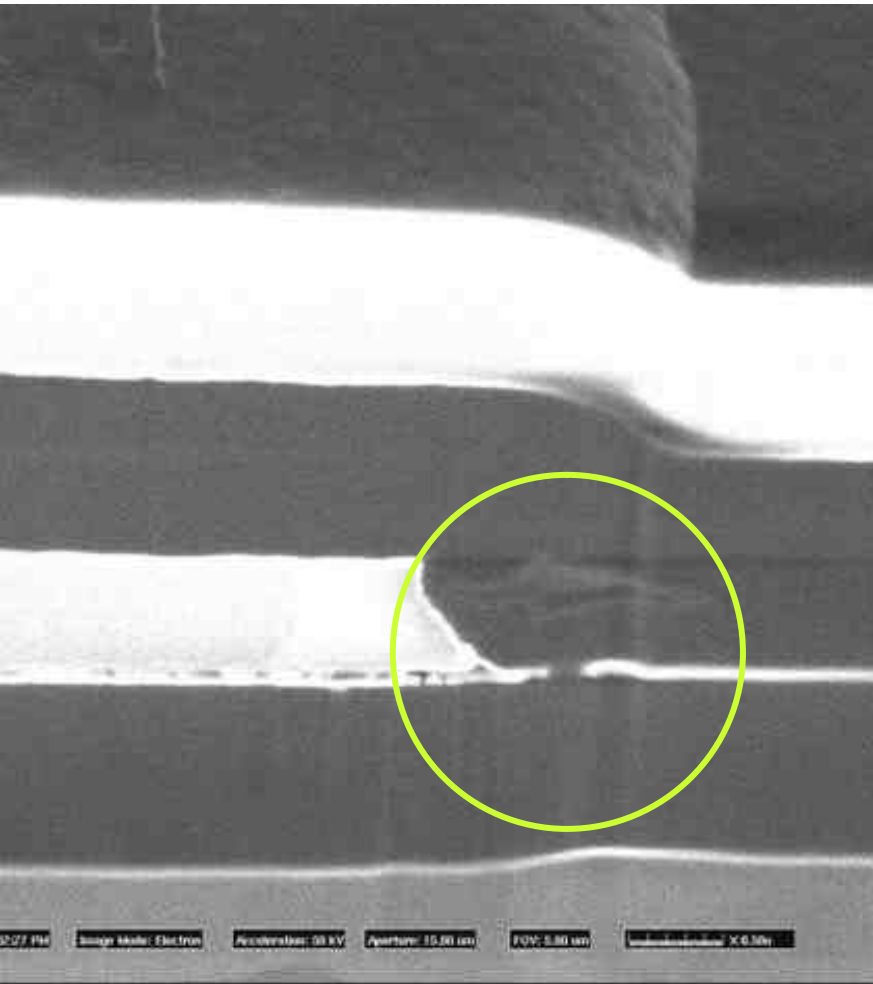
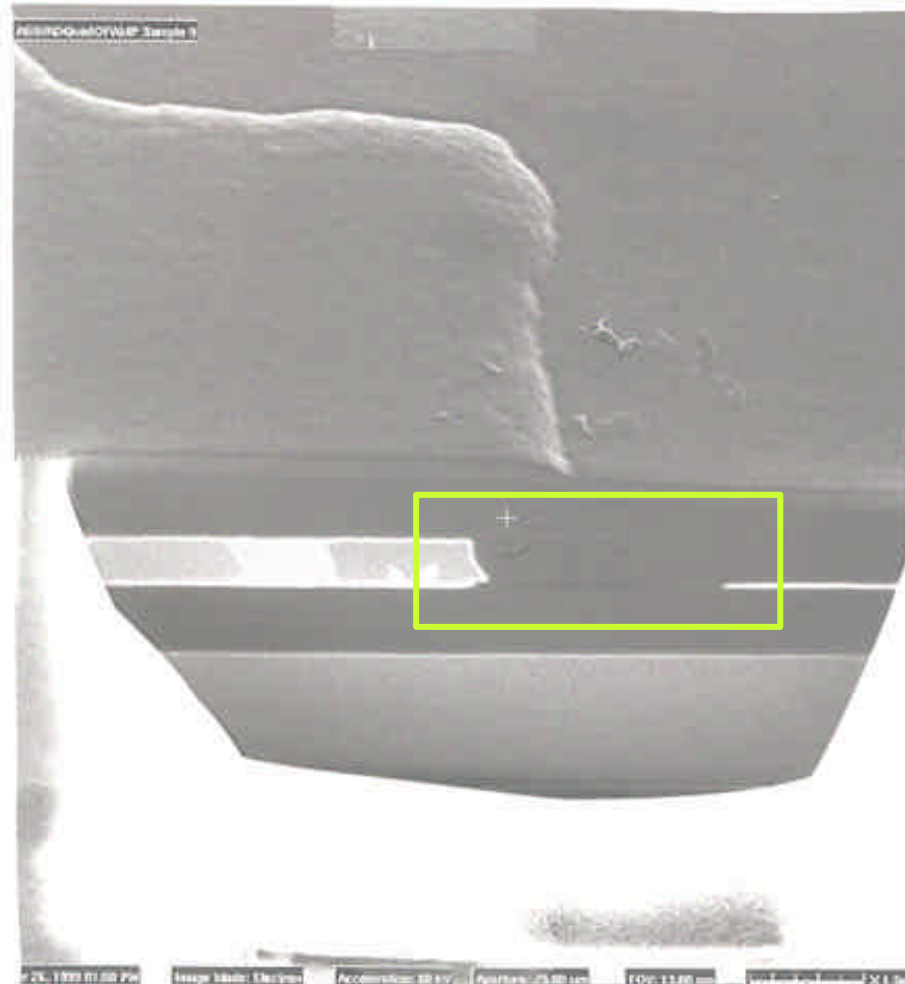
Resistor opens; IMO affected, too

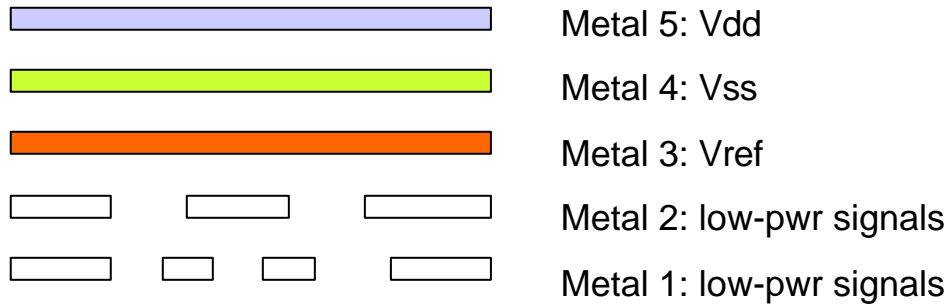
OLD

- LP-CMOS-part of circuitry with small geometry, e.g. $0,2\mu\text{m}$
 - analogue part with high current: line width up to $100\mu\text{m}$
 - filler structures, dimensions around $100\mu\text{m}$, too
 - five or more metal layers
- ➔ thermomechanical mismatch causes ILD-Cracks, which will be filled by metal over the time and cause interlevel shorts

Design-change: avoid overlapping area structures
