The difficult art of locating an ESD failure and identifying its root cause:
from physical signature to latent defect

Marise Bafleur, LAAS-CNRS

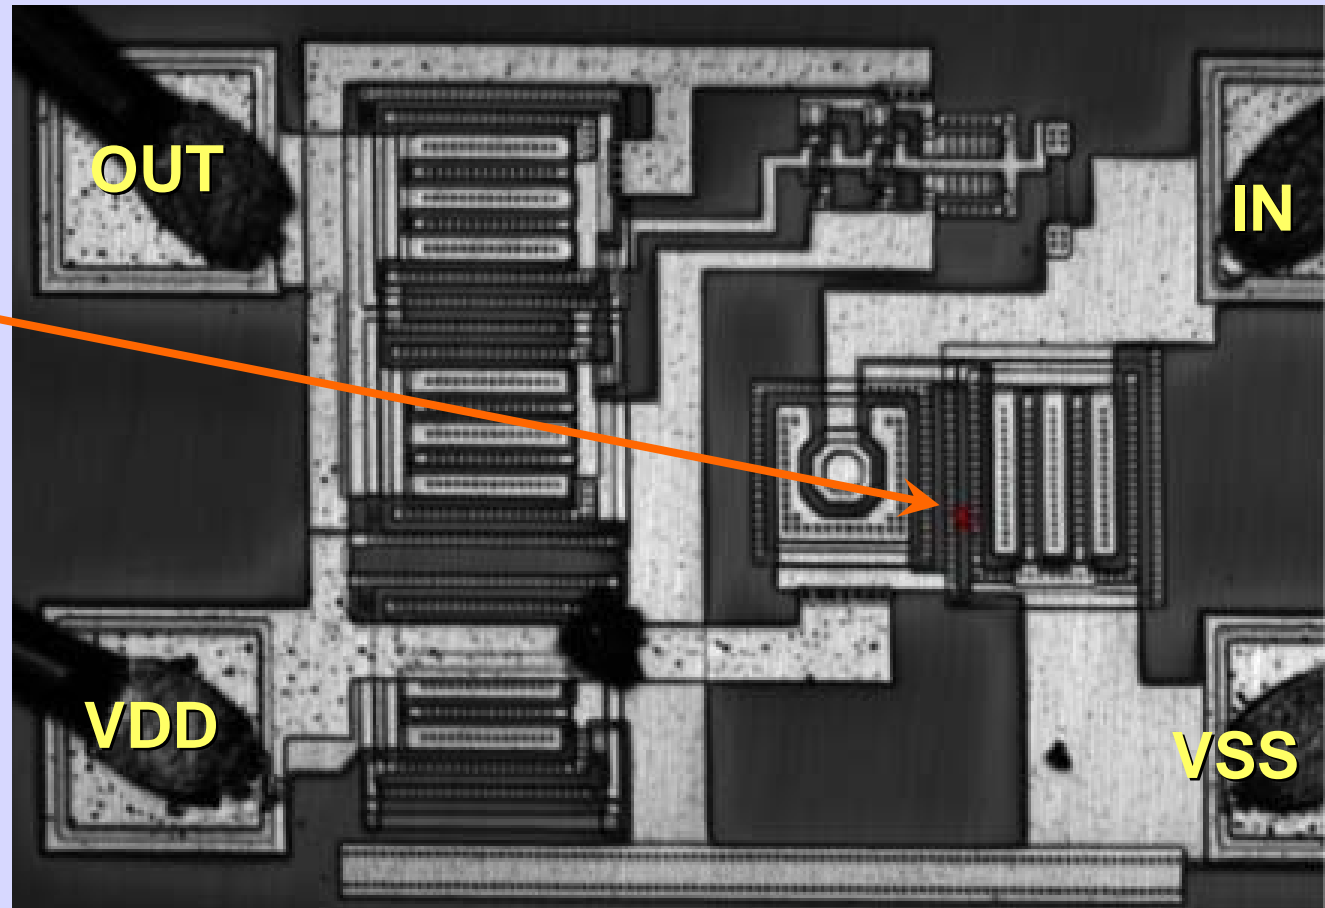
- Electrical Signature : leakage current between VDD & VSS
- Optical observation & EMMI : no defect detected

Defect localized
using OBIRCH

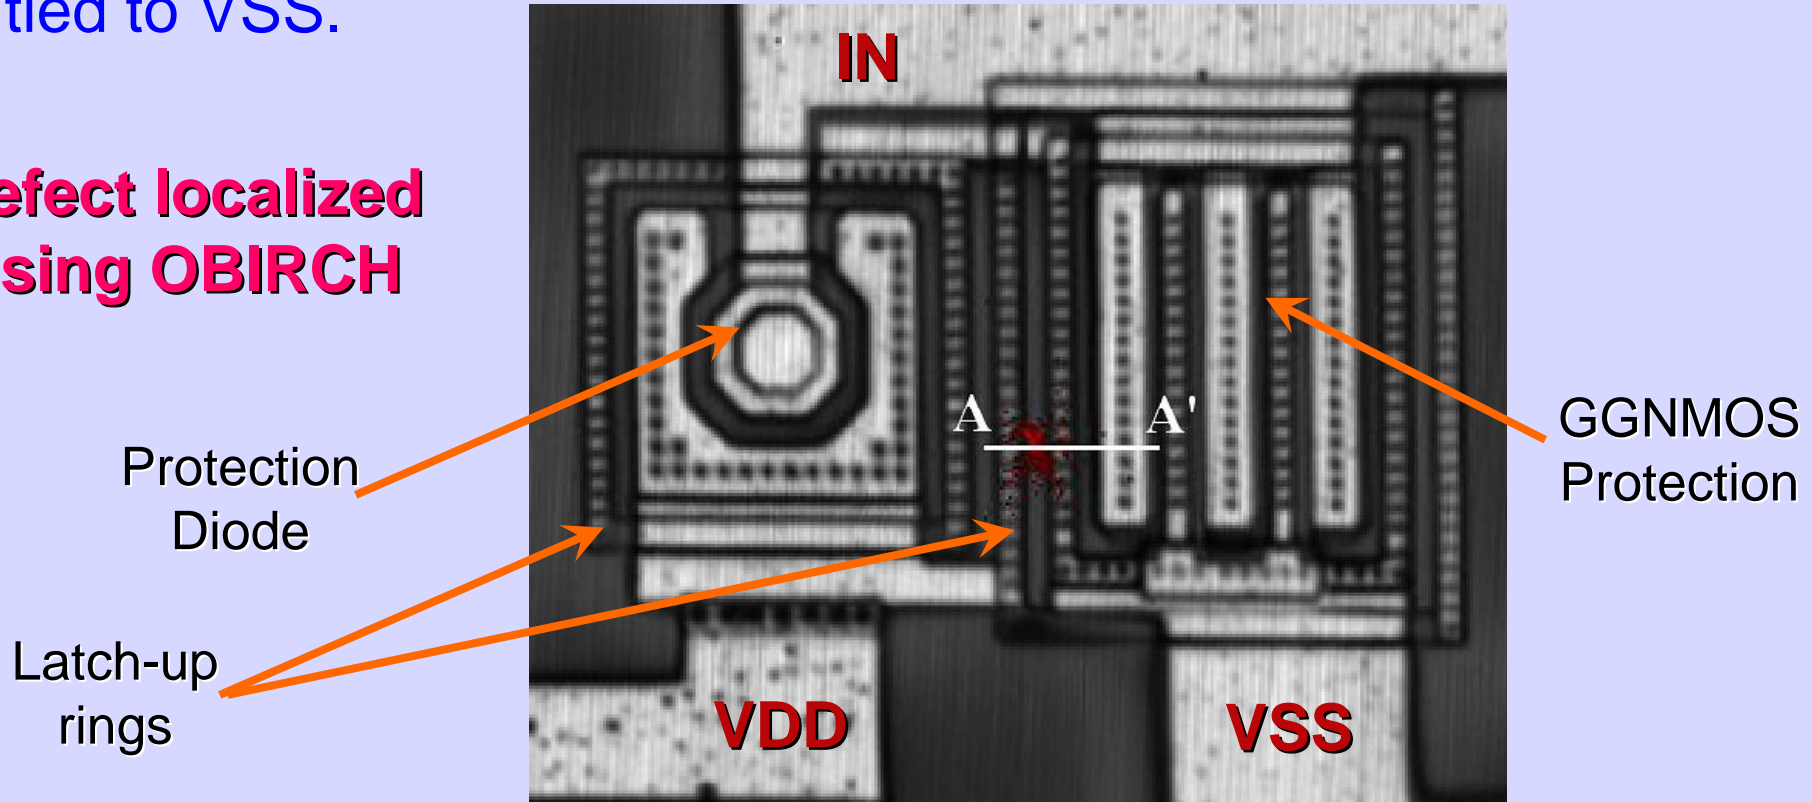
- **Electrical Signature** : leakage current between VDD & VSS
- **Type of defect**: molten Si filament between the GGNMOS latch-up ring tied to VDD and the P-substrate contact ring tied to VSS.

Defect localized using OBIRCH

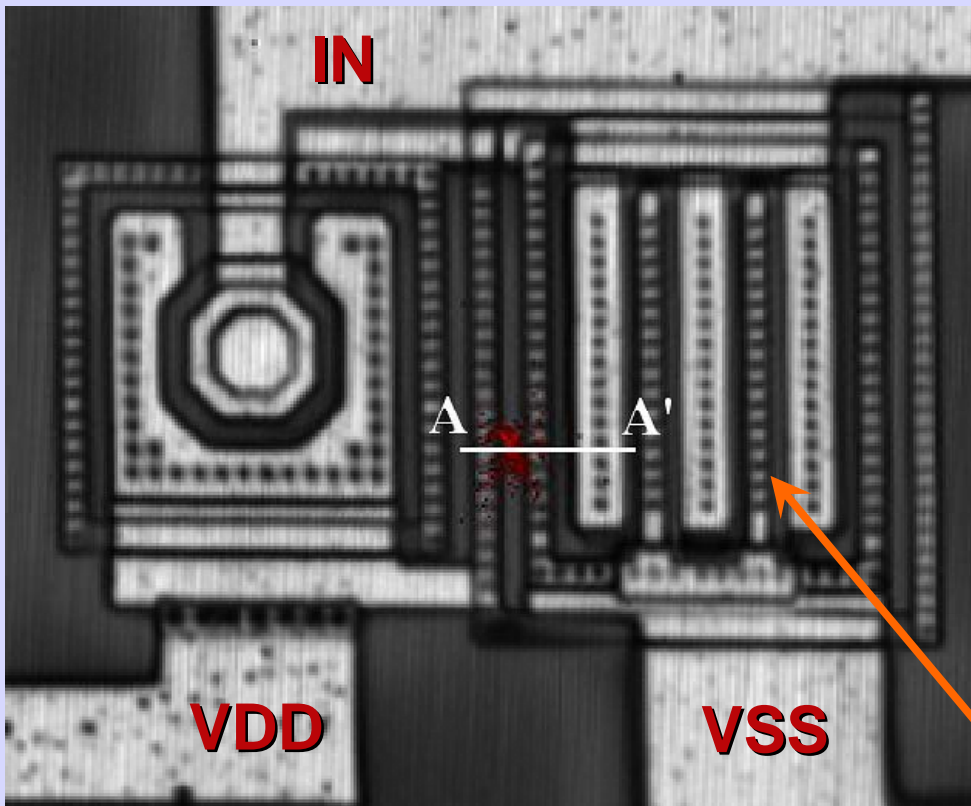
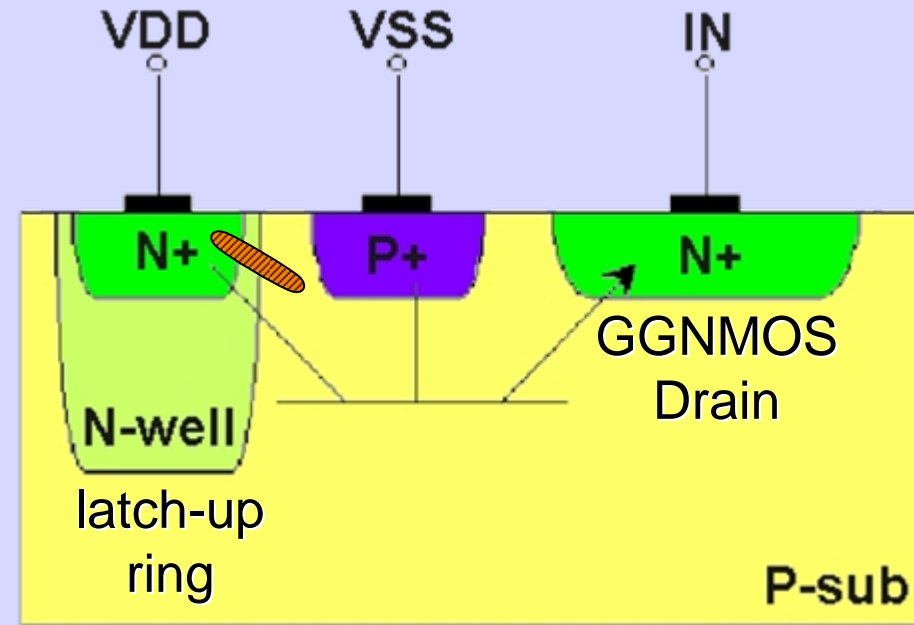
Triggering of LU ring related parasitic NPN bipolar

Local melting of Si

Corrective design action: New design rule for the latch-up ring

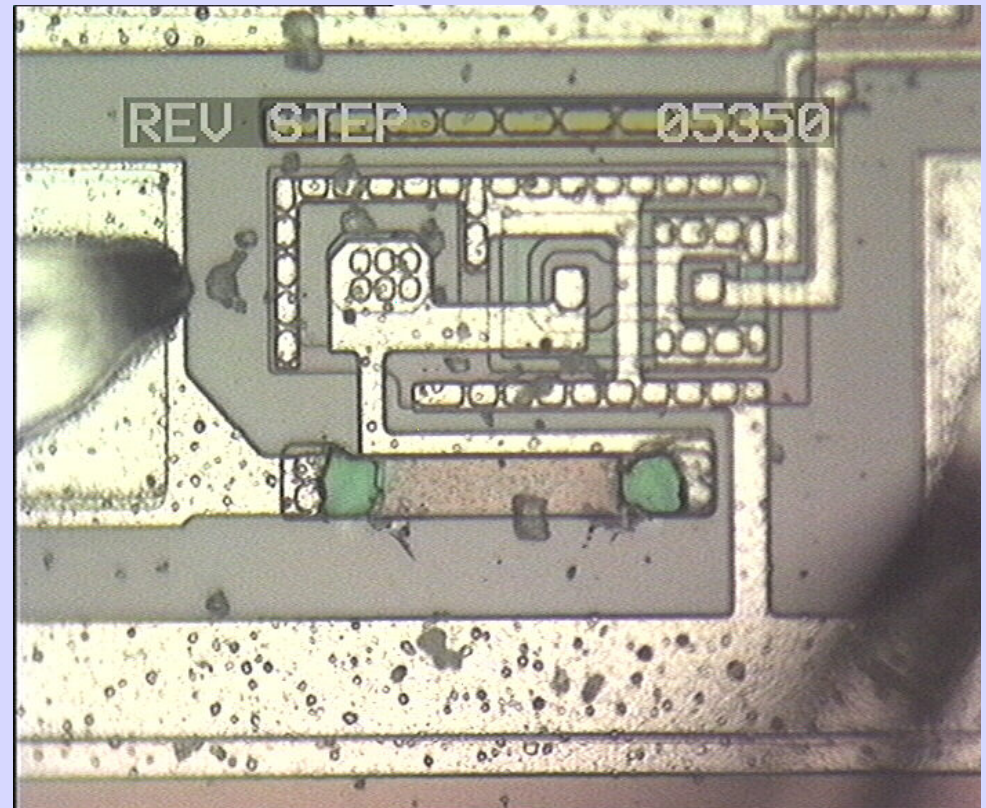
- ❑ **Context:** Field return
 - 54HC14 circuit mounted on a missile shooting equipment
 - Overstress on the input after shooting
- ❑ **Circuit provider A :** more than 50 shootings without problem
- ❑ **Circuit provider B :** 1 failure about every 7 shootings
- ❑ **Same signature on all circuits :** melting of polysilicon resistance at its 2 edges

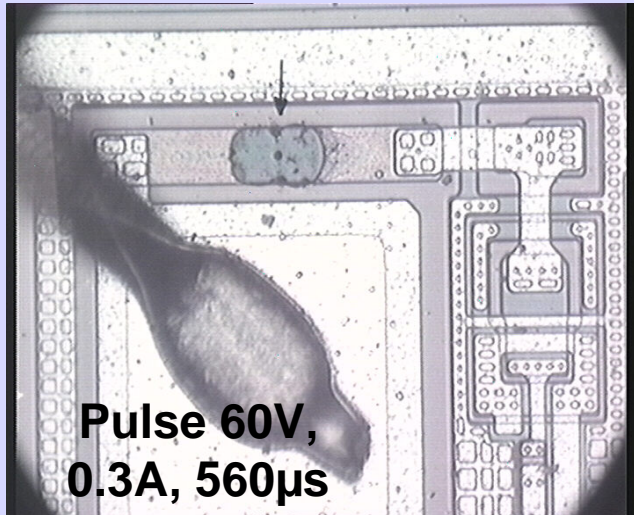
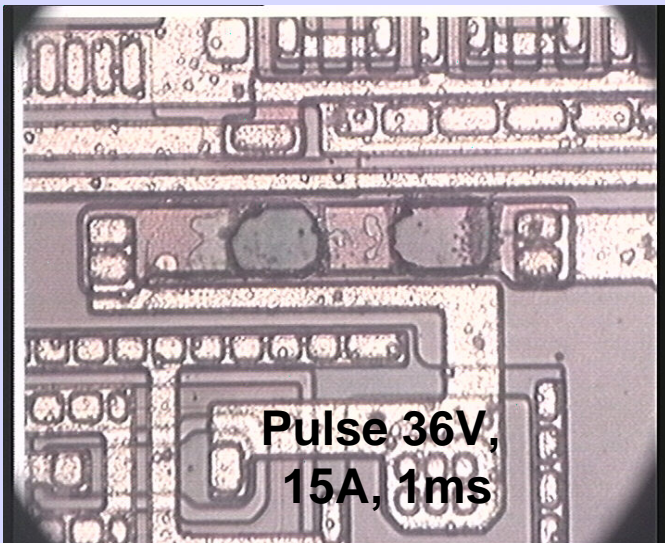
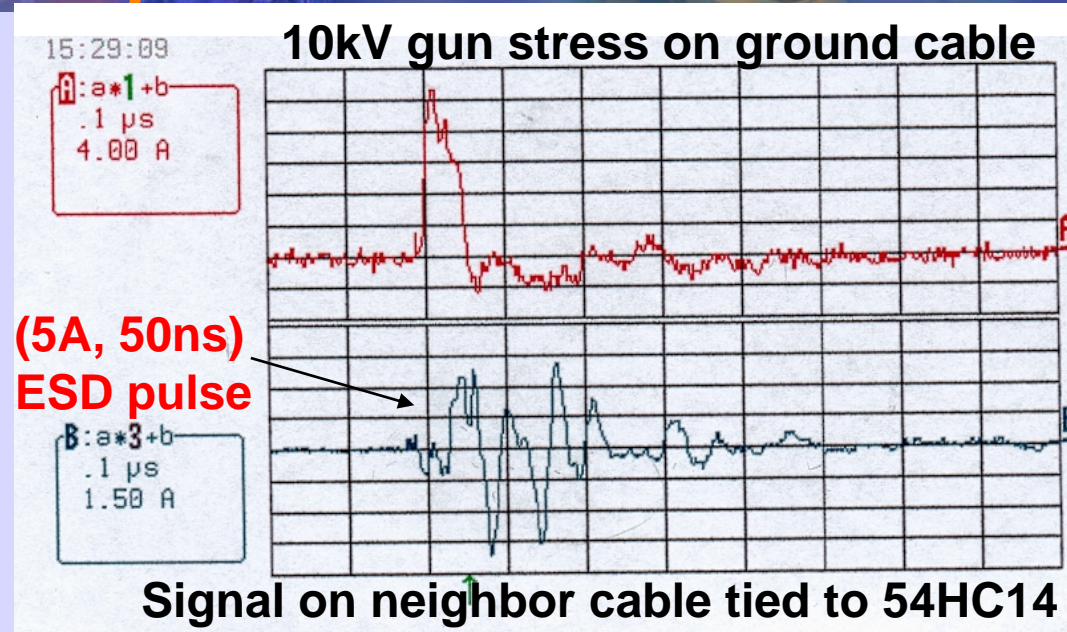
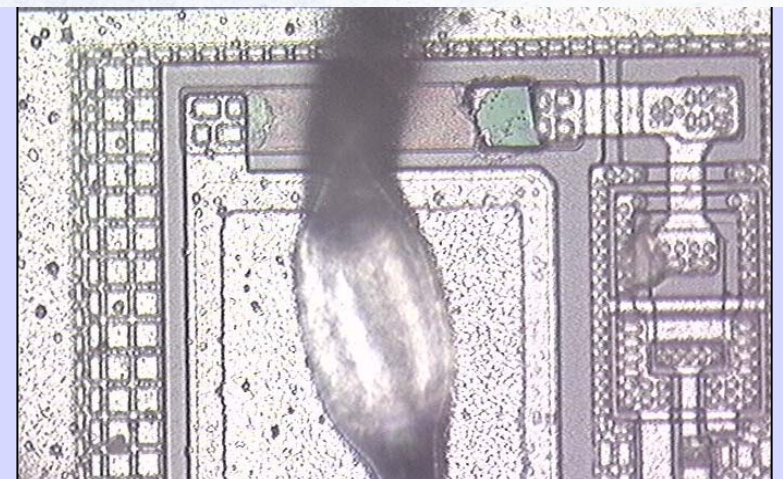
Overstress reproduction

EOS

ESD stress induced by EMI

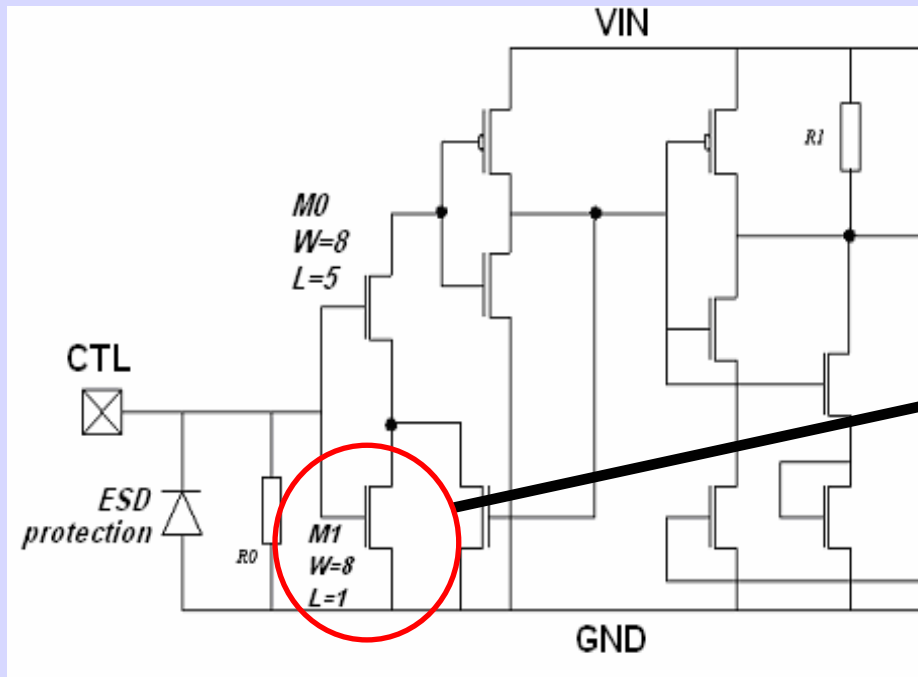
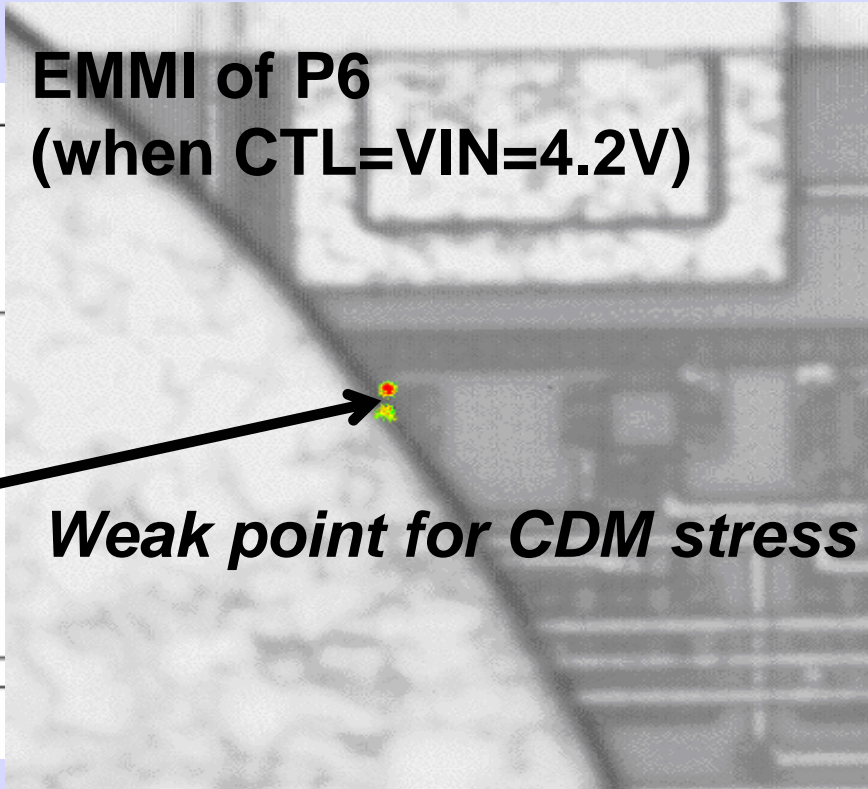
Functionality tests	EMMI
all failed	M1 gate emission for P5 & P6

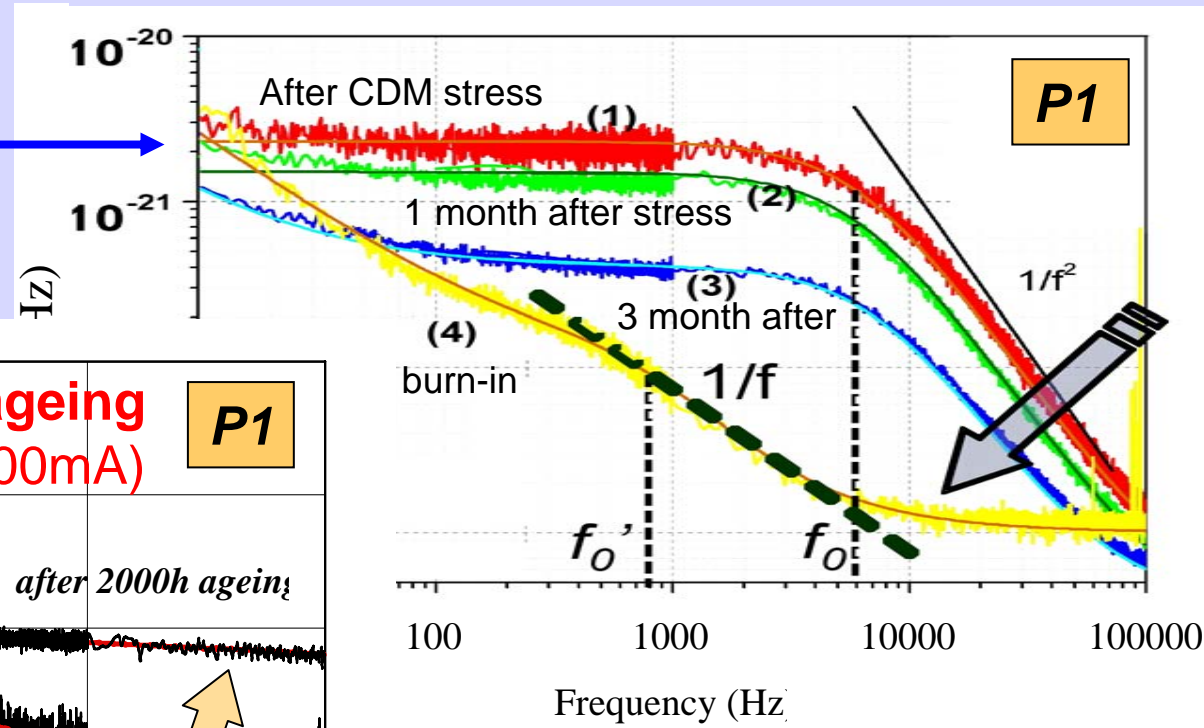
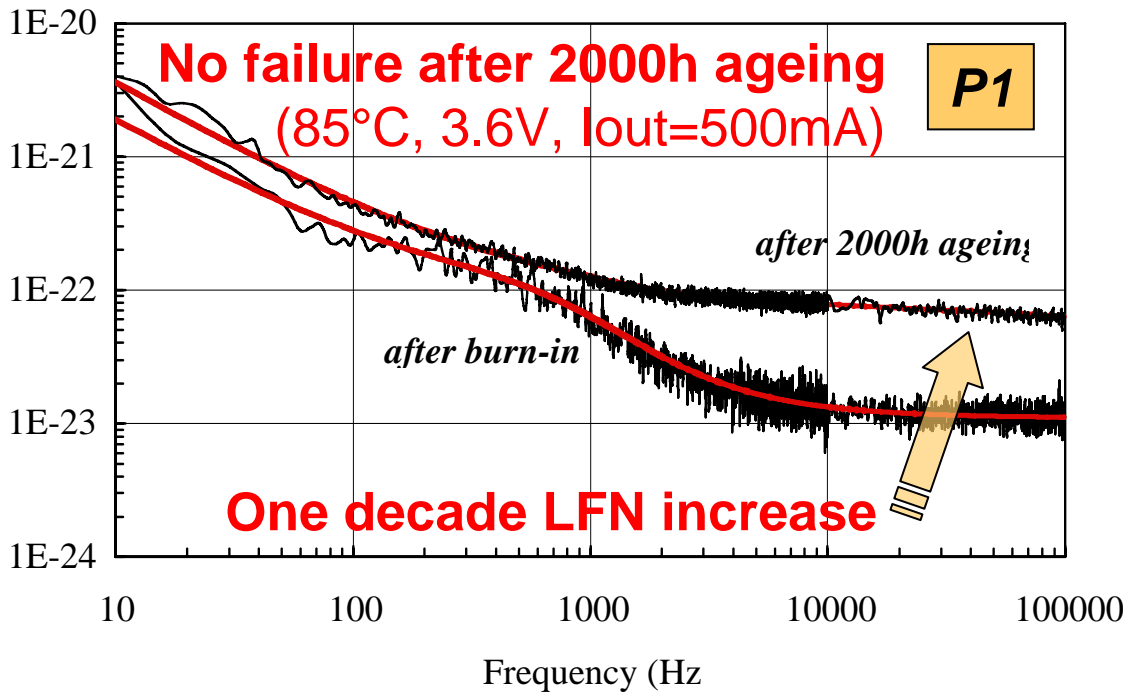
Low Frequency Noise (LFN) evolution

Oxide charge trapping

LATENT DEFECT
