TRE techniques status :

Problematic thought a case of analysis 45nm / 65nm :

Challenges regarding Crolles C045 and bellow

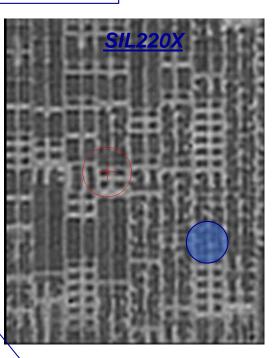
NO EMMISSION AND TRE SIGNAL @ VDDnom and VDD+20%

Probing spot observed : only on a invert or buffer

- Mandatory to increase power supply (+30%) to have a signal
- Poor optical resolution and sensor sensitivity
- Methodology to put in place for TRE probing
 - Pattern optimization (loop size, commutation only on the path suspected)
 - Strong relationship with design and test

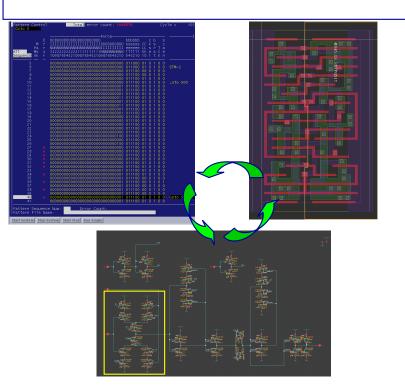
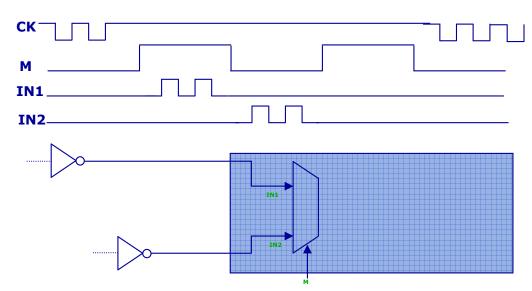
- Tool and "method" calibration versus the part will be analyzed
 - Probing on all the reference signals, on reference cell
 - Behavior on TRE signal on invert, buffer, stdcell, NAND, NOR, ...
 - Display (low emitter with high emitter), signal processing, ...
 - Parasitic emission, artifact, ...
- Probing on the failing cell
 - Validation on TRE signal
 - 2 or 3 different pattern (change the timing)
 - Sensor moves (limitation of blade use to collect a maximum of signal)
 - ...

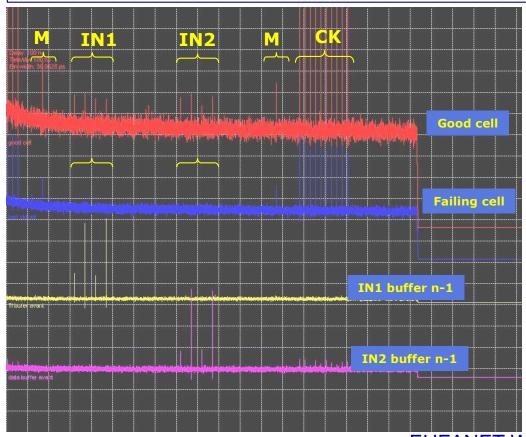
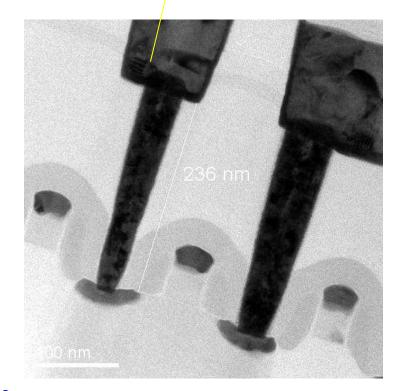
- Acquisition Time
 - More than 10min @ VDD+30%
 - Signal processing during acquisition
- Analysis
 - The size of contact suspected => bad CT resistivity
 - Simulation in correlation => Electrical stuck@

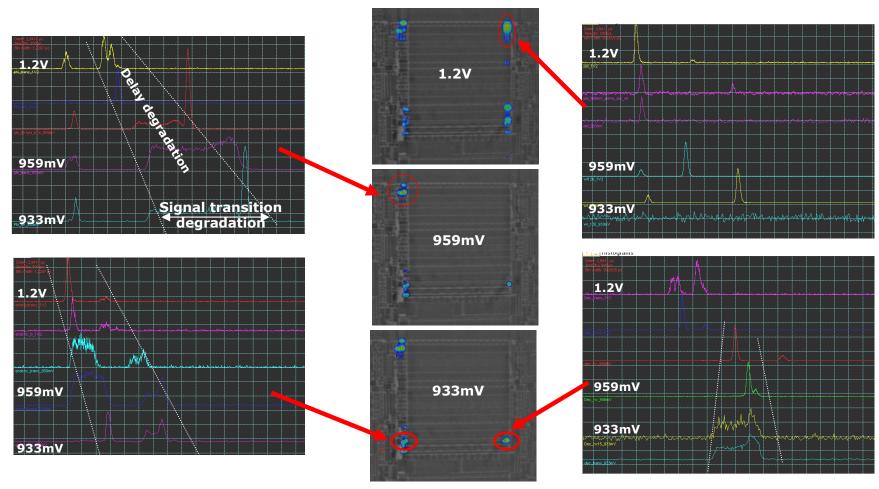
- The less power supply decreasing, the more Emission increase
- Poor optical resolution in mapping mode
- Strong relationship with designer to understand the peek behavior
 - Simulation mandatory
 - Very well design understanding
