HAMAMATSU THEMOS Mini Evaluation

WMM, C&P Failure Analysis / GNB Failure Analysis Lab EUFANET

Optical Localization Techniques Workshop

26 & 27/01/09

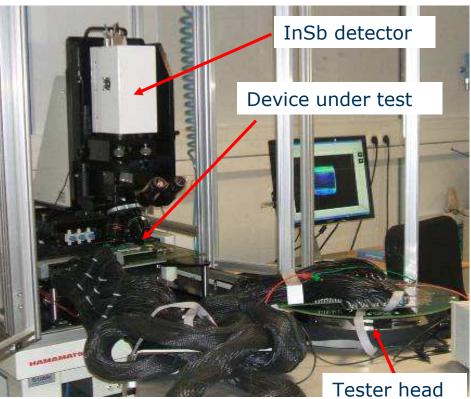
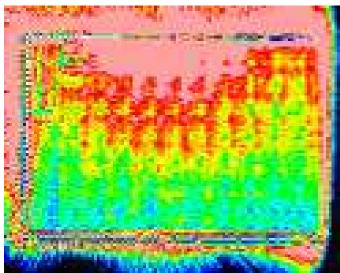
Techno : CMOS090

- Temperature is higher on the edge of die close to areas from bandgap to PLL.
- Heat signature is almost the same between the 2 lots, just a little higher on fast lot.

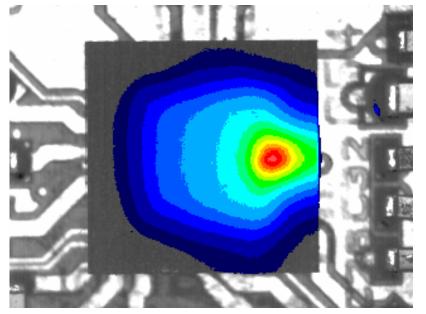
Sample 1: unit is running, heating phase

- Thermal mapping acquisition is done with an application board.
- Package is not decapsulated.
- Feedback from our internal requestor:
- There is no thermal camera matching our needs, temperature value measurement with an accuracy of +/-5°C.
- Option available Q2/09

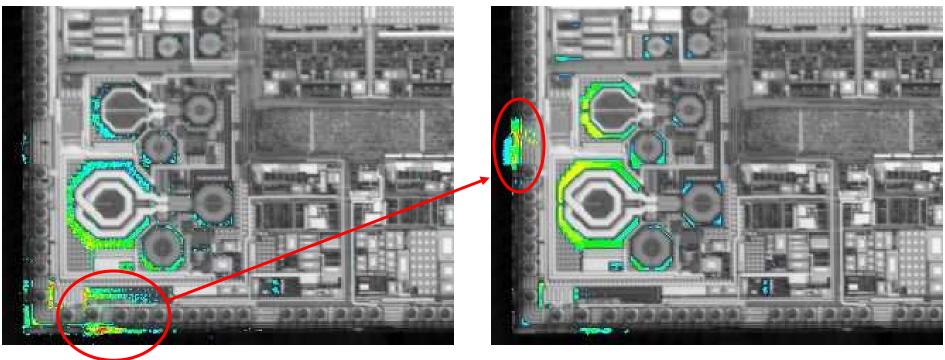
B. Latch-Up issue / Techno : XXX

Latch-up – clamp 100mA

No latch-up

Hot spot in a specific pad just before triggering the Latch Up (this pad is the source which delivers the current sunk on C1NI bloc). Then a very intense hot spot is detected on ESD protection structure once the LU is triggered.

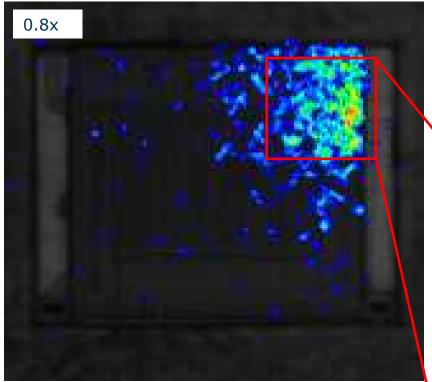
C. Leakage issue / Techno : XXX

- Leakage on Vdig 10 µA vs 1 µA for a Ref.
- Obirch analysis done with no abnormal signature.
- Thermal analysis shows hot spots close to Vdd pads.
- → Damages are seen on die edge probably due to a bad sawing.

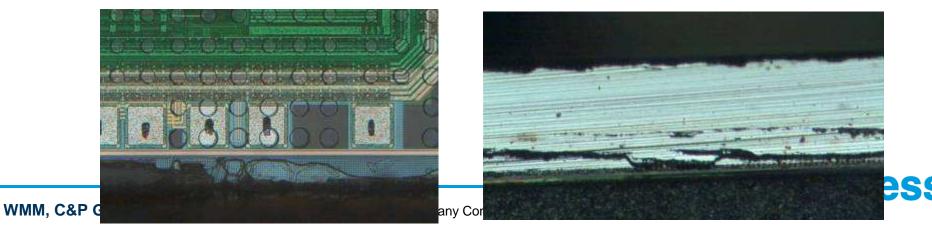
- Leakage on Vana 1 mA vs 1.5 µA for a Ref.
- Obirch analysis done with no abnormal signature.
- Thermal analysis shows hot spots at the bottom right corner of the die close to Vana pad.
- \rightarrow Damages are seen on die edge probably due to a bad sawing.

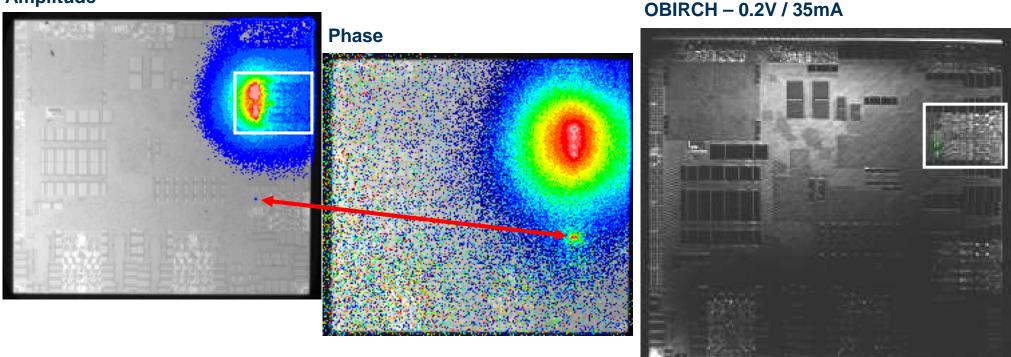
D. EOS reproduction / Techno : XXX

- Leakage 0.5V/100mA after stress.
- Localization with both OBIRCH & Thermal analyses.
- Interest of phase information, small spot is seen in amplitude but the area is heating at the same time compare to big spot area. → same cells damaged.

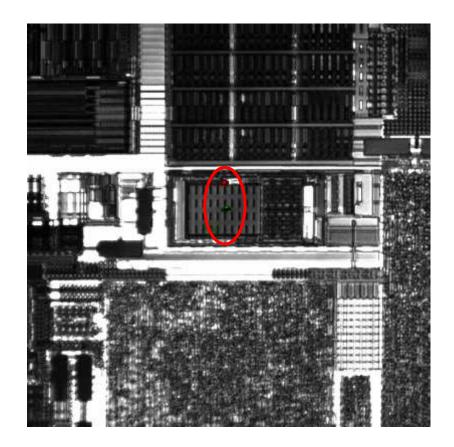
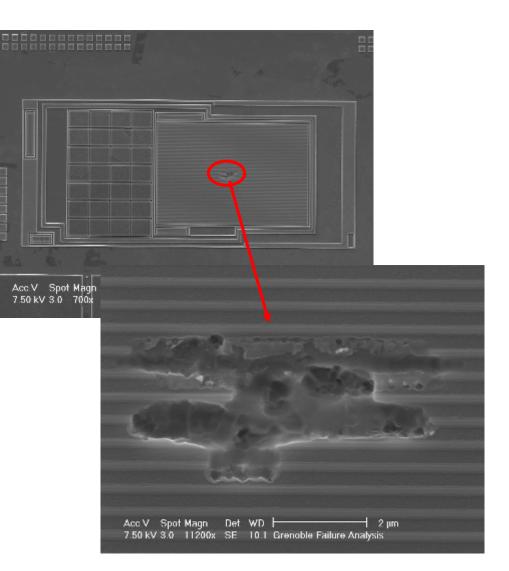
The 'CLAMP_1V0_ANA' structures on VTT are damaged: silicon melting interconnect blow-up (contacts fused) and gate oxide breakdown.

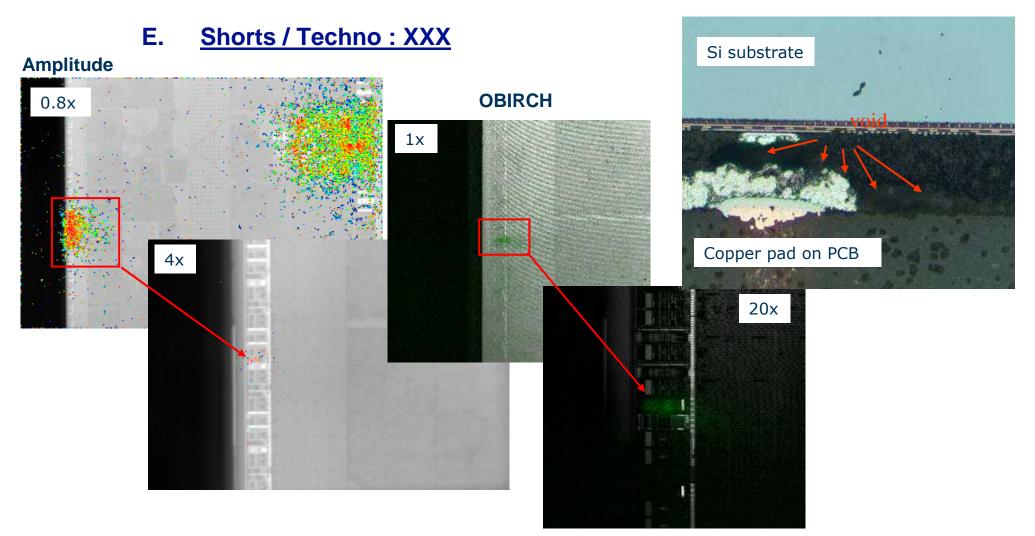
- OBIRCH & Thermal signatures are not localized in a "specific" structure and are quite diffuse: an issue under the active area of the die is suspected (back-end / bump level).
- The failure modes observed are voids in underfill, a solder extrusion and a metal migration in bump.

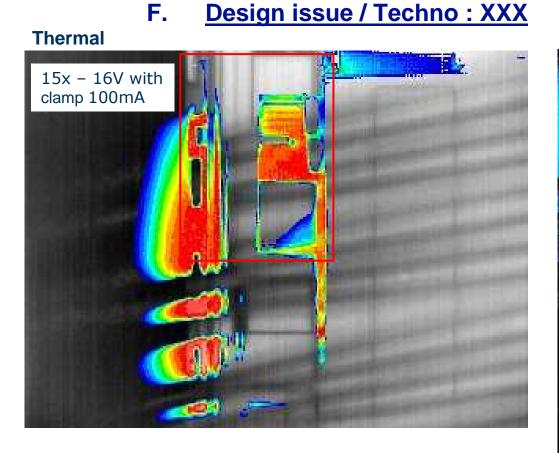
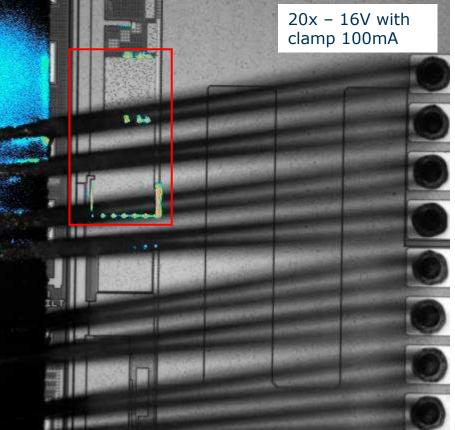
ILLESS

- Charger issue: fast charger connection up to 16V is breaking the phones.
- The movie capability of Themos mini was used to locate easily the failure. Then photos are generated when the fail is triggered.
- Emission localization was performed and emission is found above the driftswitch when the current is latched.

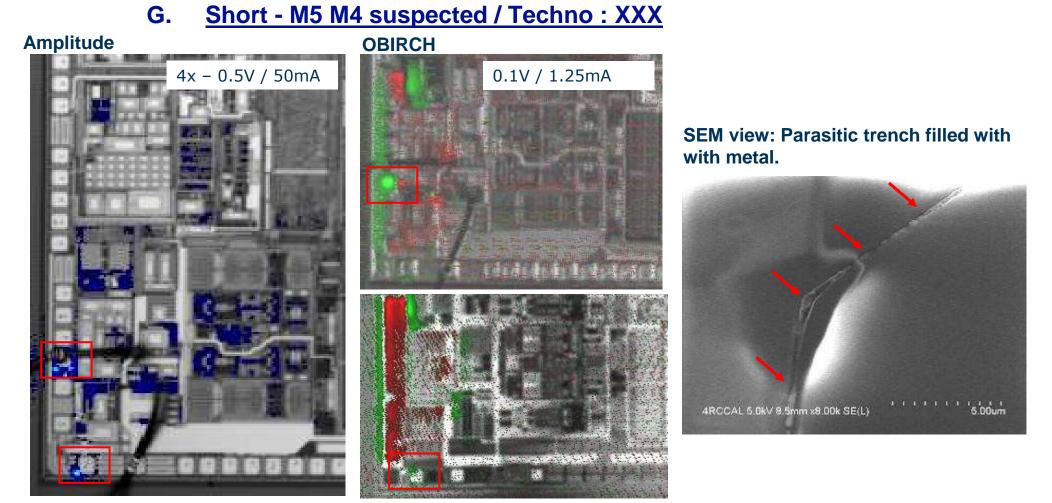
- Short 0.1V / 1.25mA.
- Good result BS vs FS (0.8x & 4x), Better FS result @ 15x (Top layer level issue suspected)
- Two thermal spots localized, less noised than OBIRCh signature.
- Parasitic trench filled with metal creating a short between M5 & M4 layers.
 WMM, C&P Grenoble FA LAB
 Company Confidential

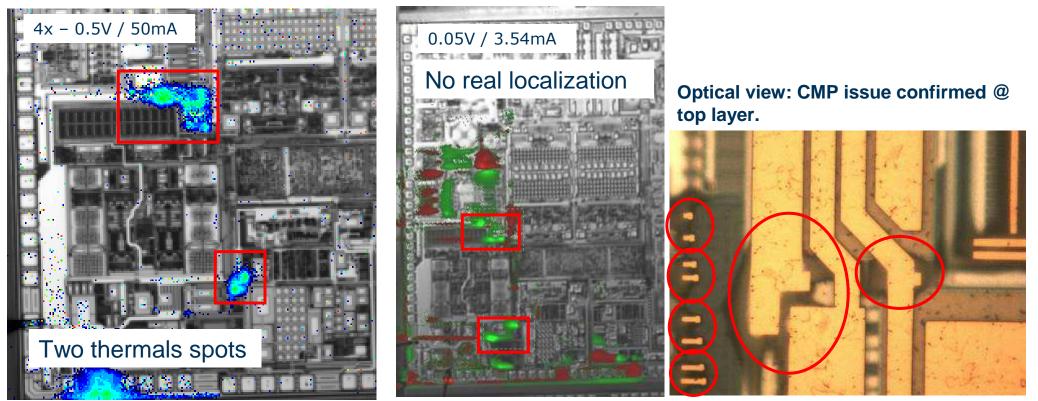
H. Short - CMP M5 suspected / Tecno : XXX

- Short 0.05V / 3.54mA.
- Good result BS vs FS (@ 0.8x => 15x)
- Lock-In has a real impact on localization
- Two thermal spots localized in comparison of OBIRCh signature.
- CMP issue is confirmed.

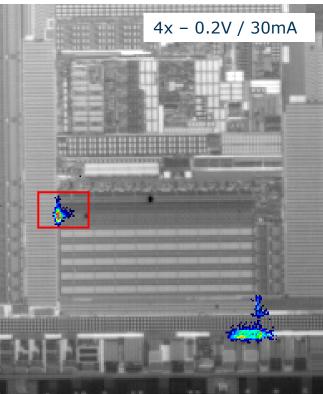
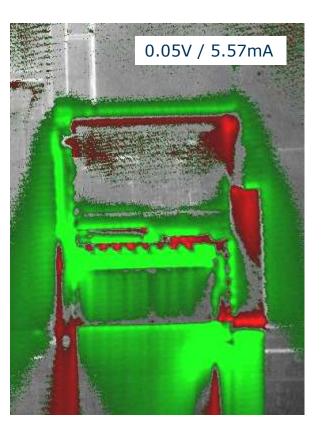
- Short 0.05V / 5.57mA.
- Good result BS vs FS (@ 0.8x => 15x)
- Lock-In has a good impact on localization
- One thermal spots localized in comparison of OBIRCh signature.

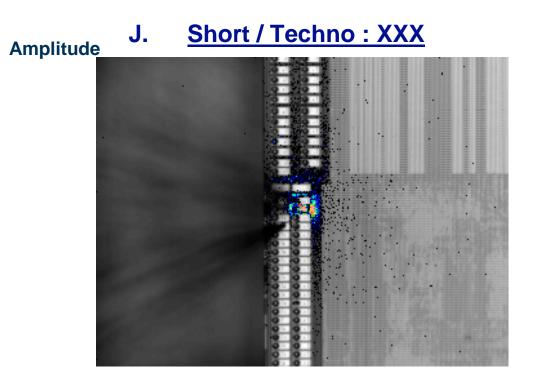
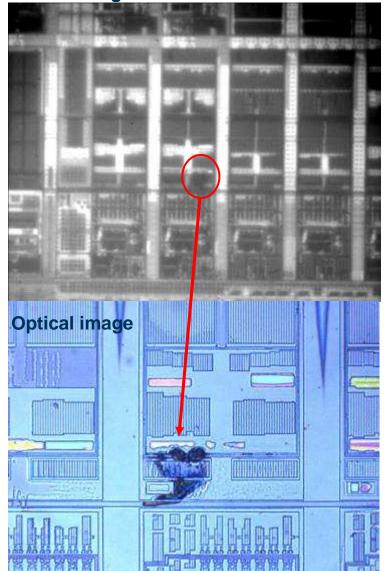
InGaAs image

- Even if no spot was visible either with OBIRCH or EMMI, an accurate backside visual inspection performed with InGaAs EMMI detector showed a burning on the active area in the failing pad.
- By thermal camera equipment we managed to see an anomalous dissipation of power in the area of the failing pad.
- We then proceeded by quick de-processing to reach the active area, finding out the final confirmation of the presence of the burning.

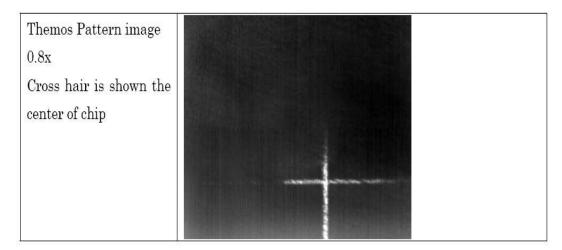
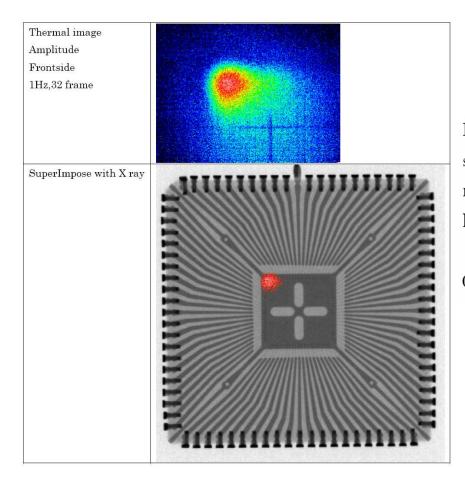
1.2 Evaluation with Themos

In the X-ray image, we can not see Si, but can see bonding wires. Thermal signal is observed around bonding wire area, which leads the guess that there may be something wrong under Si. Thermal signal is not round but looks like having a tail toward right direction

Open the package from backside for further investigation.

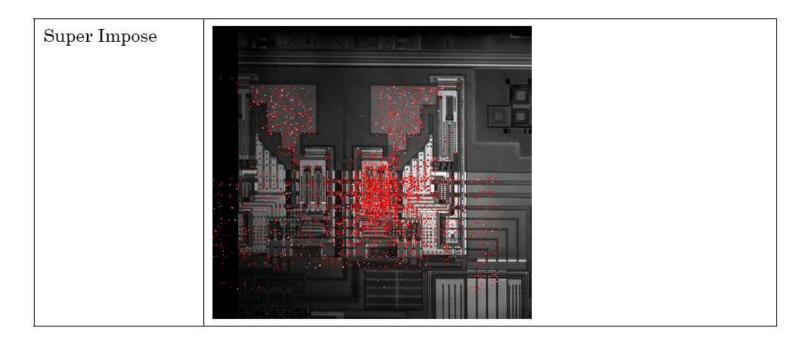
Thermal signal is observed around bonding part on Si. There is another thermal signal observed at left side of large one. We guess this small spot causes a tail in the signal we observed on the device surface.
