NXP : Dynamic Laser techniques

Application examples

Frank Zachariasse
EUFANET Workshop
Toulouse, January 2009

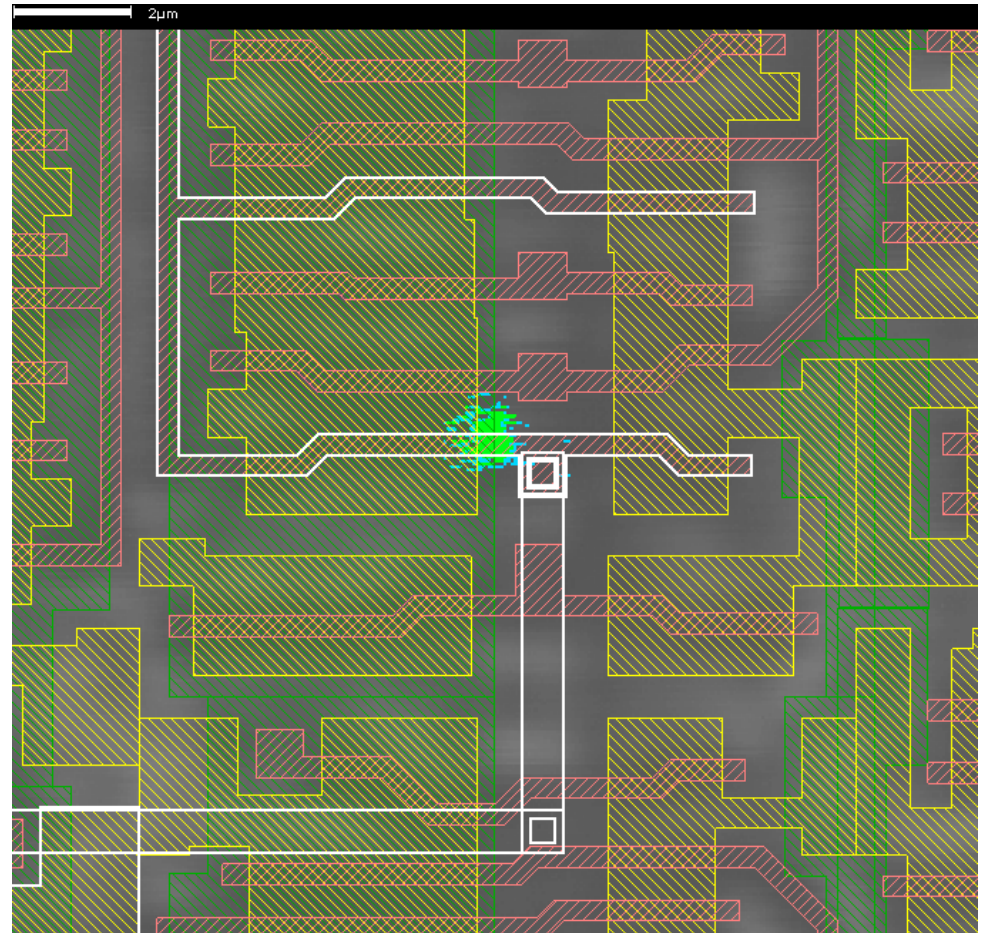
Perform DLS on delay fault test

- ▶ Make special tester pattern
- ▶ Repeat test, in a loop
- ▶ 1064nm laser scan
- ▶ Back side access to IC
- ▶ Result : 1 spot, one one of the possible nets
- ▶ The spot is exactly on the P/N junction of the polysilicon

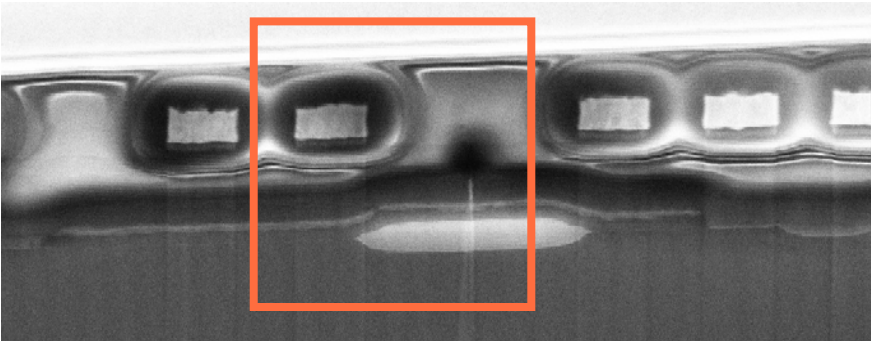
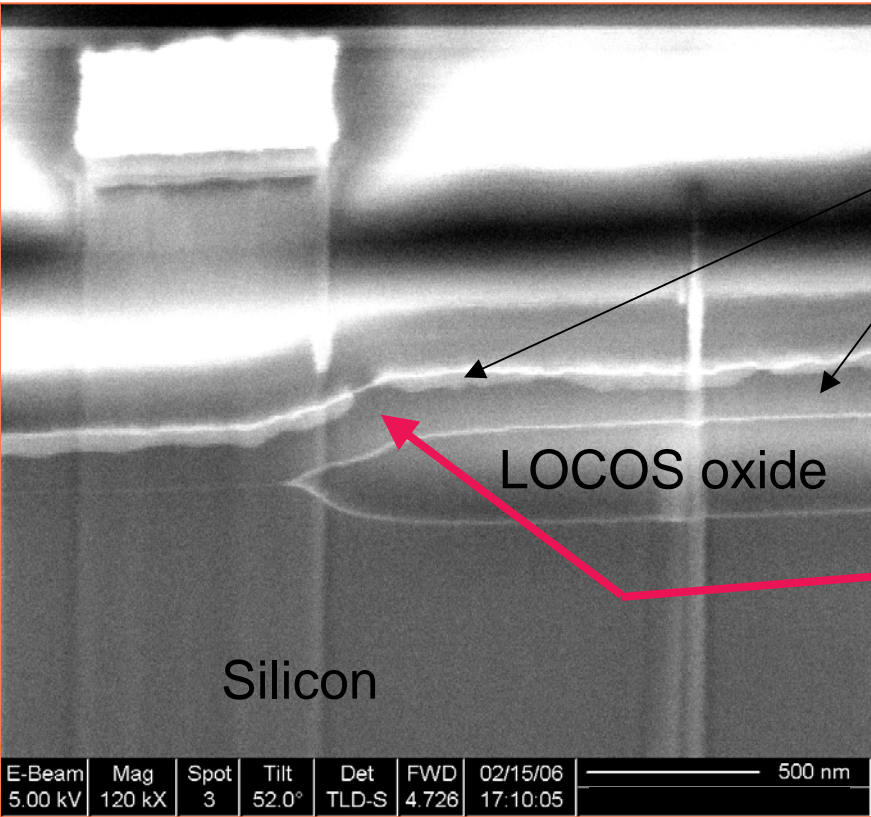
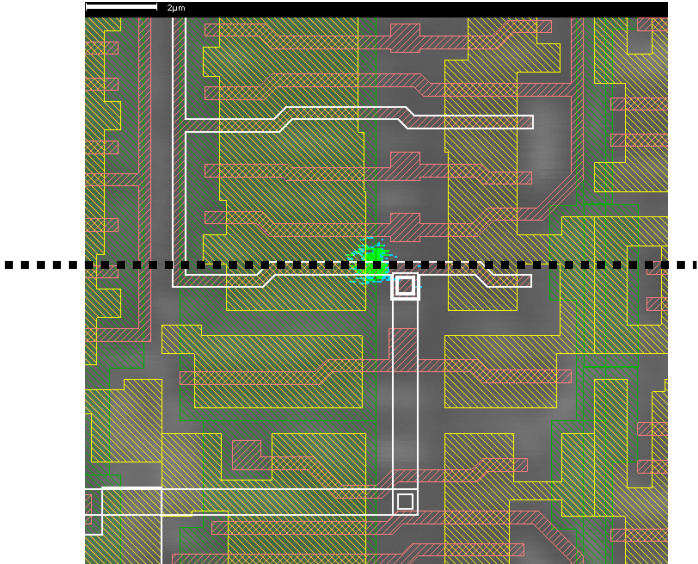
Cross-section Analysis

Missing Silicide across
PN junction – hence a
diode is formed

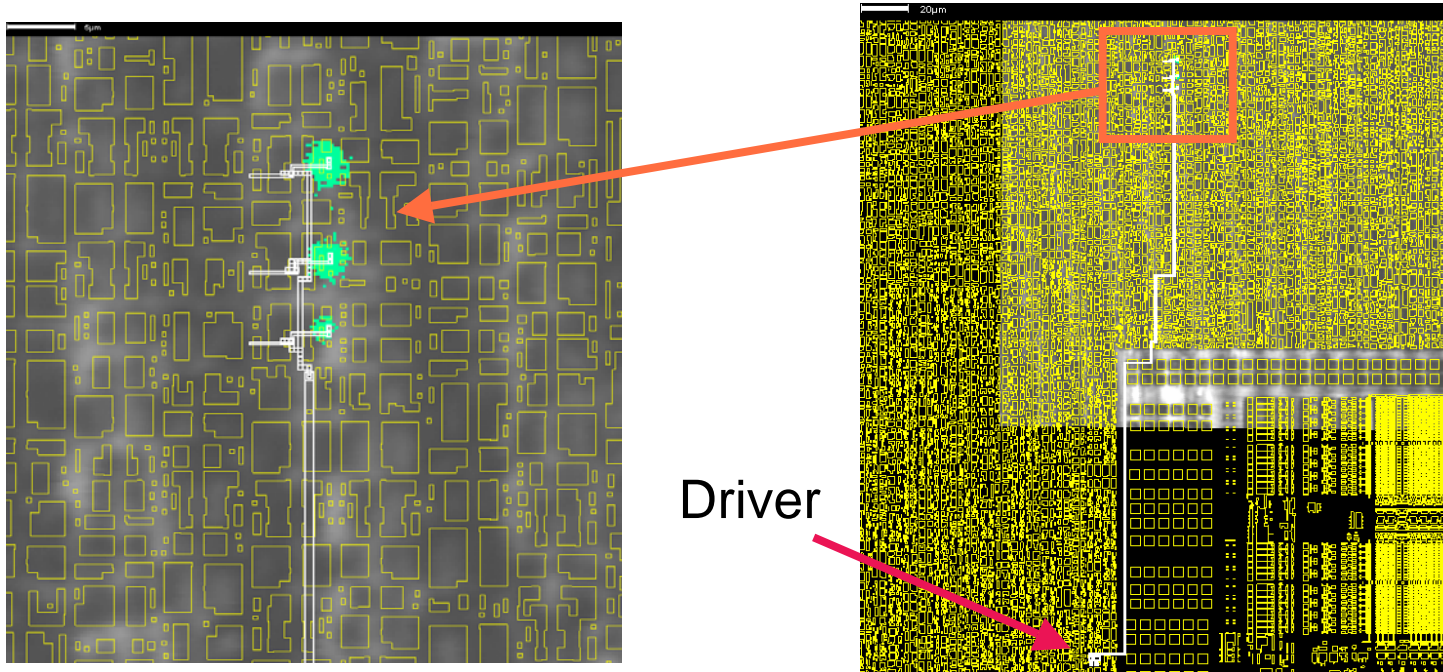
Back side Laser scan

- ▶ Response to laser (1340nm) at protection diodes, at receiver end
- ▶ No response at Driver end. This suggests open circuit
- ▶ It is unlikely that the fault location is at the 3 spots found
- ▶ Probably metal open, but can not see it from the back side (blocking metal)

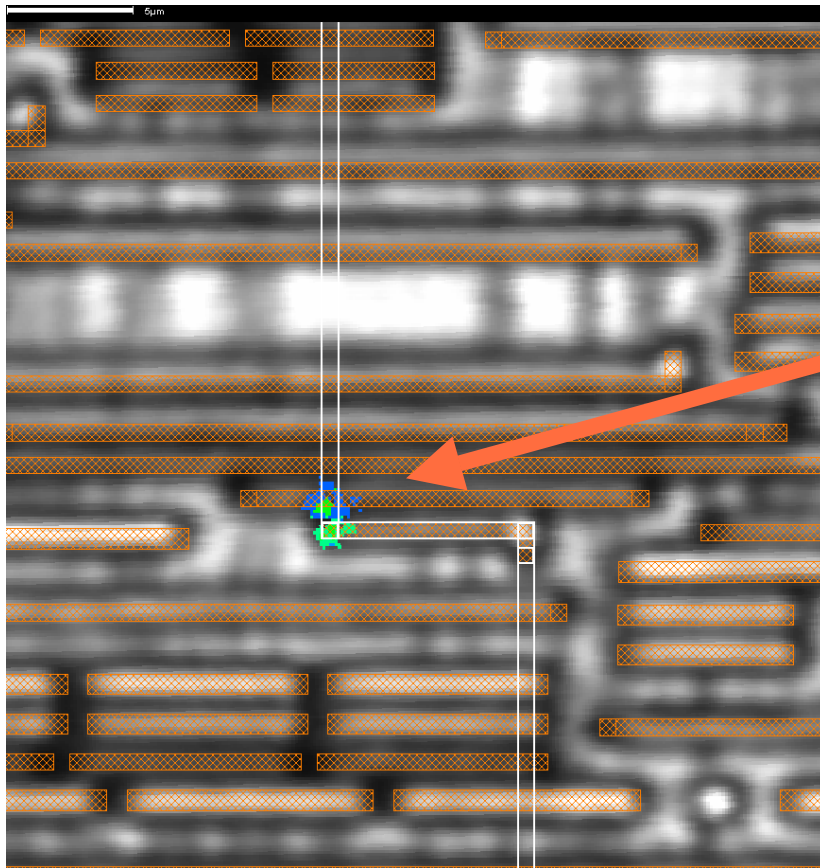
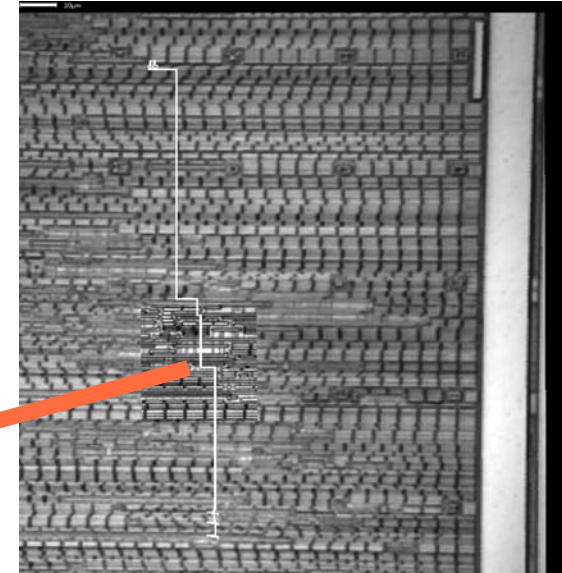
Front-Side Laser scanning

- ▶ SDL response at a VIA5
- ▶ No other spots.
- ▶ Likely that this VIA is the fault
- ▶ Make TEM XS, material analysis

Overlay, with M6 shown.

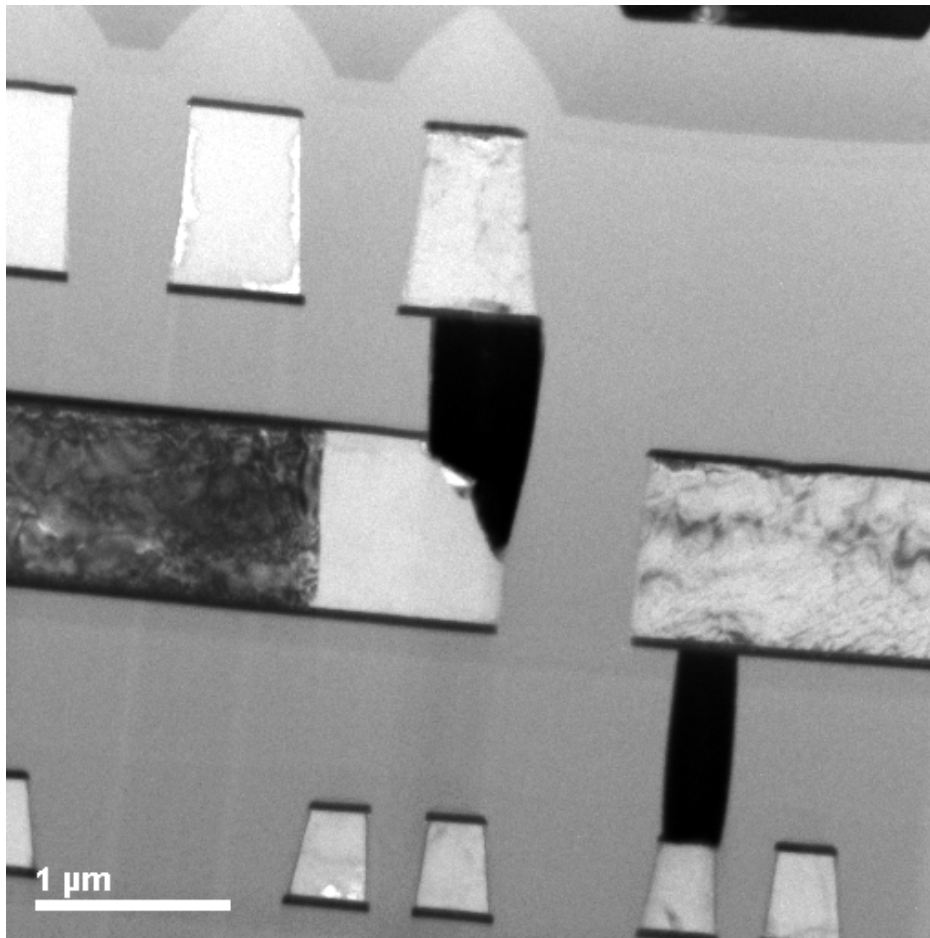
TEM XS

- ▶ VIA Alignment error
- ▶ Caused via to form poor contact
- ▶ Void and oxidation at interface

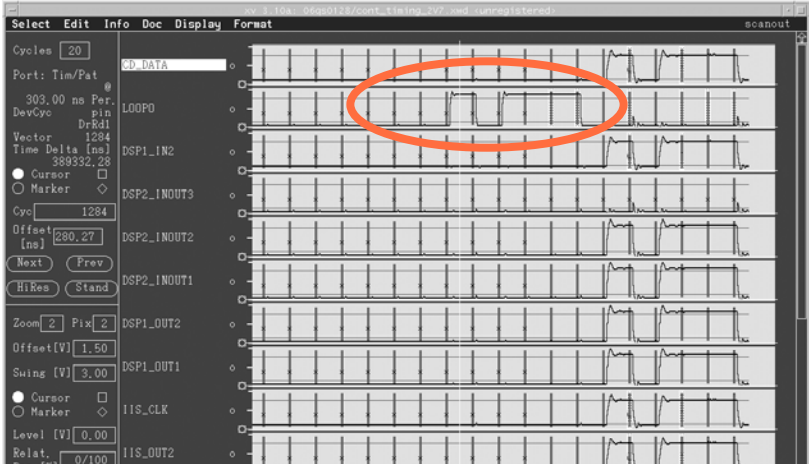
Data "10111" arrives 7 cycles too soon at output 'loopo'

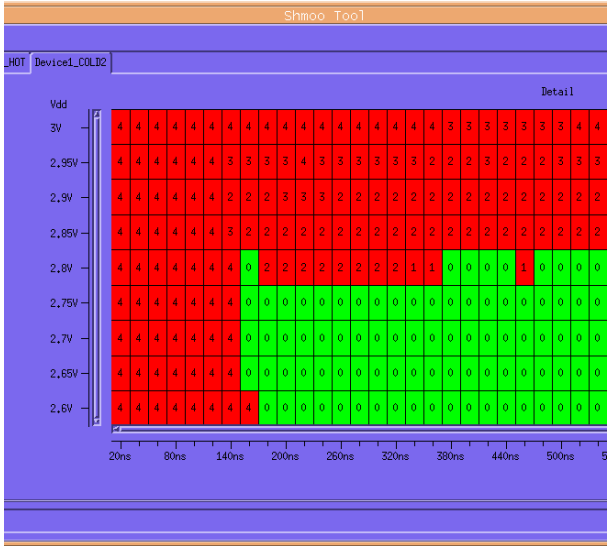
- ▶ Made new test pattern and shmoo
- ▶ Shmoo suggests SDL is possible

Fewer fails

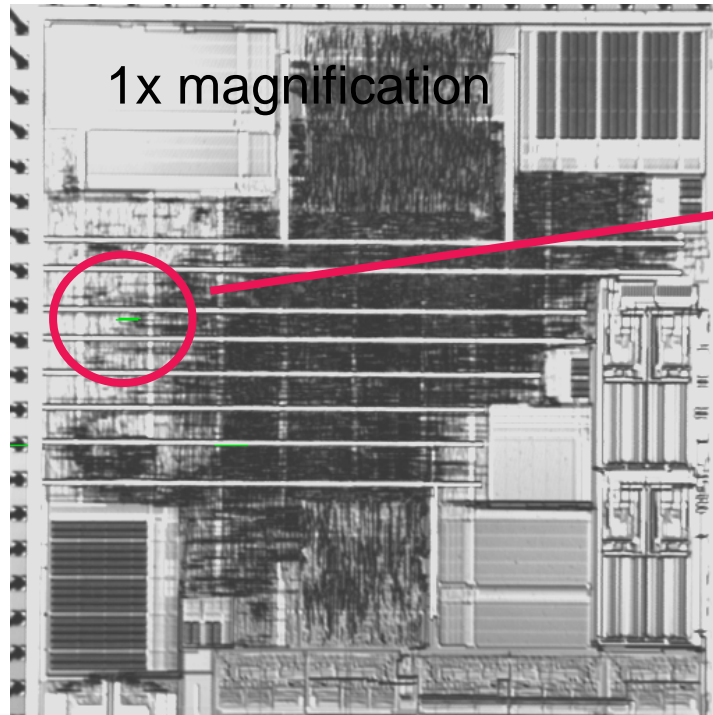
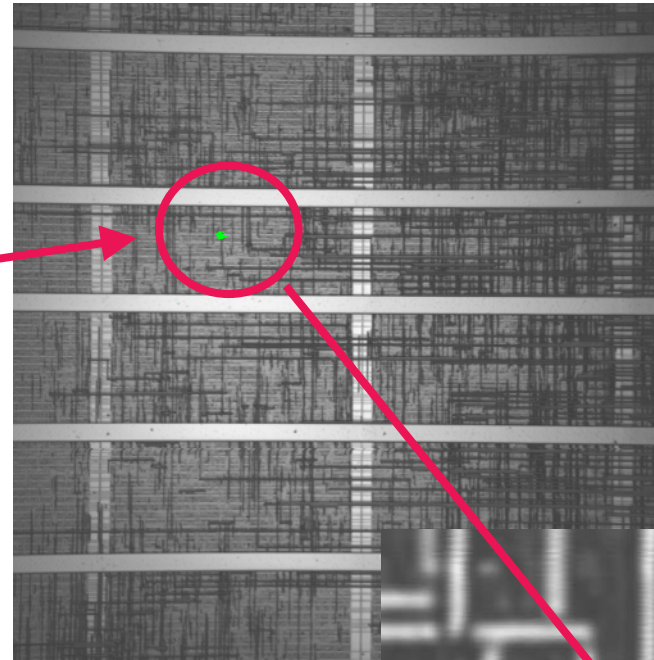
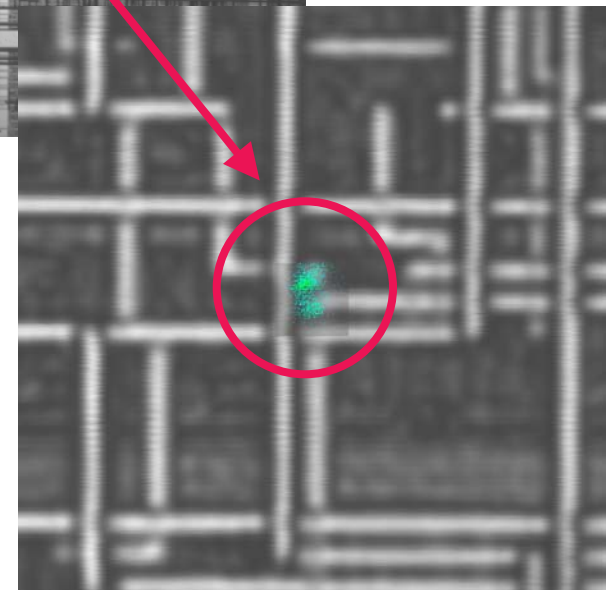
SDL localization

- ▶ Front-side SDL (1340nm laser)
- ▶ Zoomed in by stages
- ▶ One spot only on clock tree net.
- ▶ But what is the cause ? Short circuit, open ?
- ▶ Get additional information from photoemission

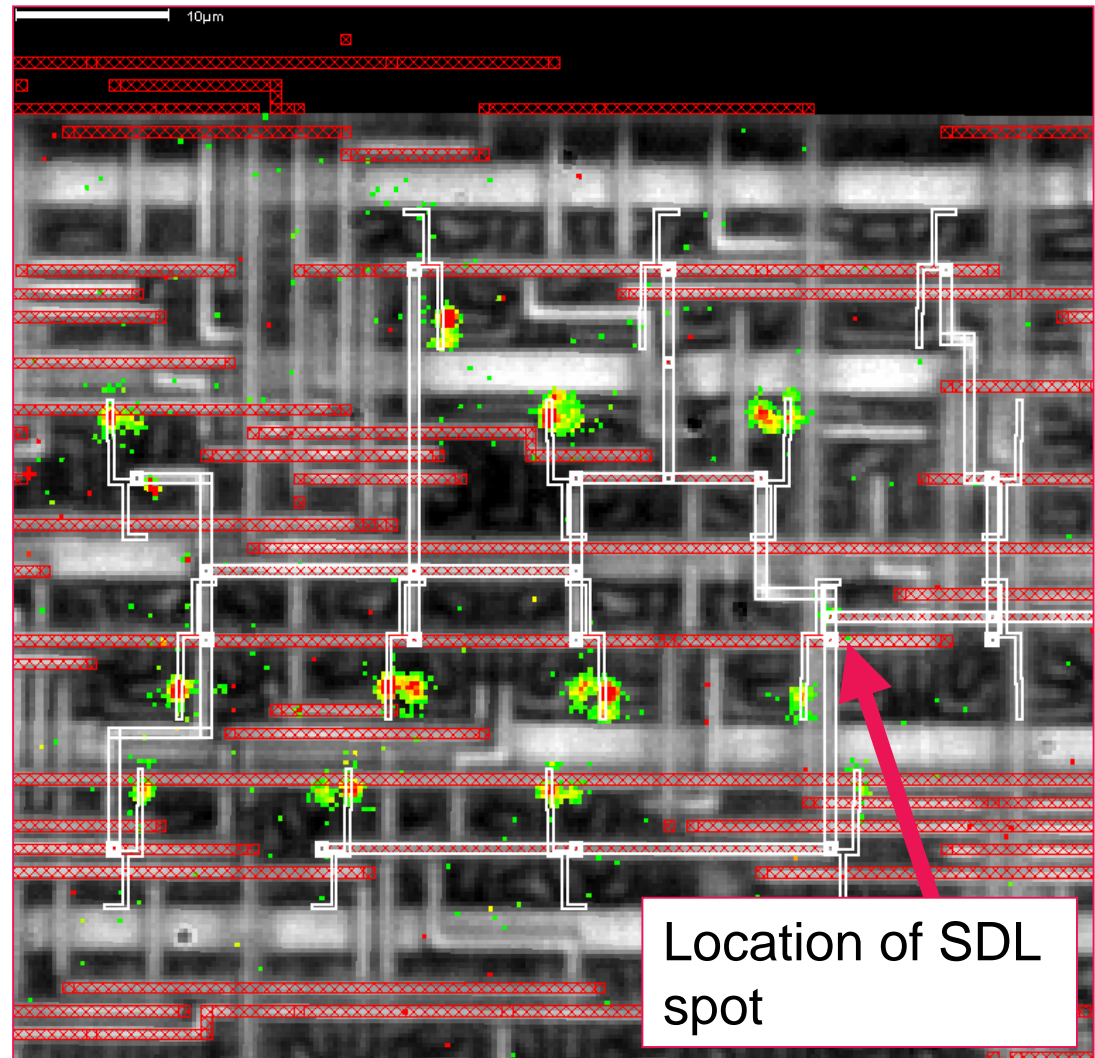
Dynamic PEM

- ▶ Dynamic photoemission
- ▶ Shift '10111000', repeatedly, high speed
- ▶ Collect photoemission while IC is clocked
- ▶ Shows emission spots only at those flip-flops, that are AFTER the suspect location
- ▶ This suggests a resistive VIA in the clock net

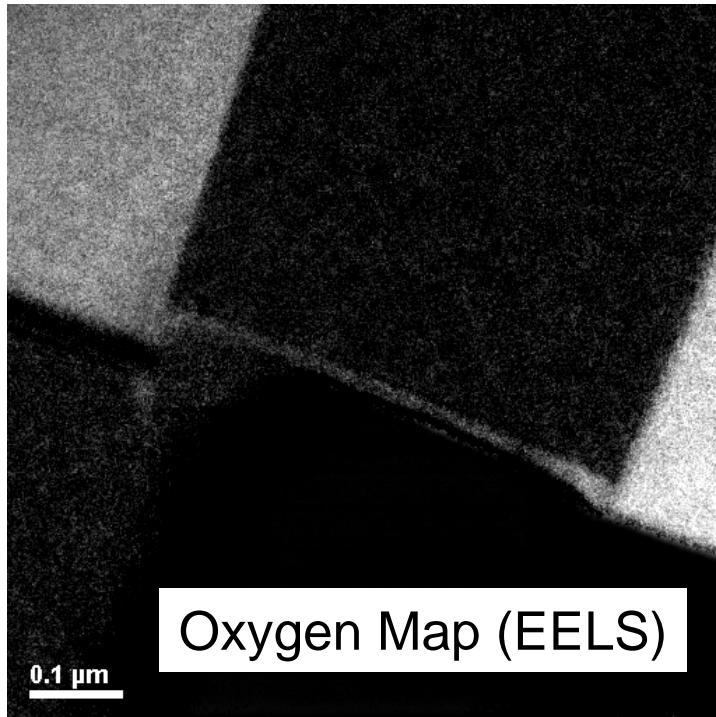
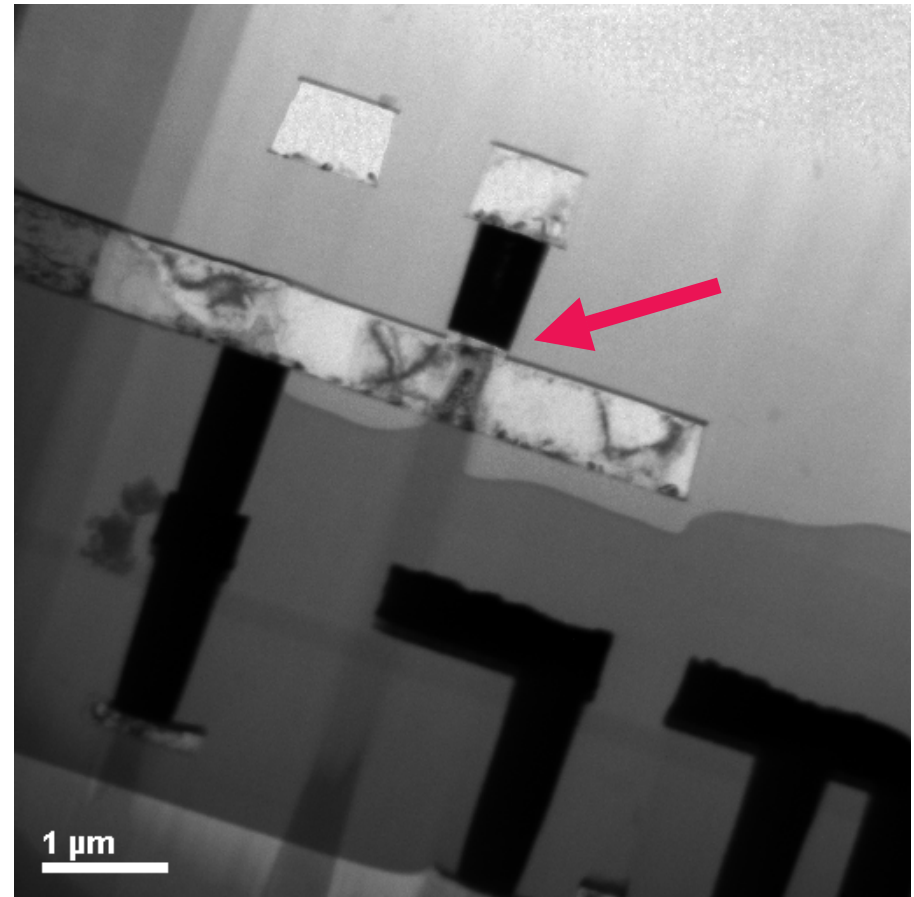
TEM XS – Root Cause

- ▶ Cross-section of suspect VIA
- ▶ TEM Materials analysis
- ▶ Shows oxidation at interface – resistive VIA
