**Design analysis in analog circuits
enhanced by Emission
Microscopy and laser based
techniques**

Christof Brillert

Infineon Technologies AG

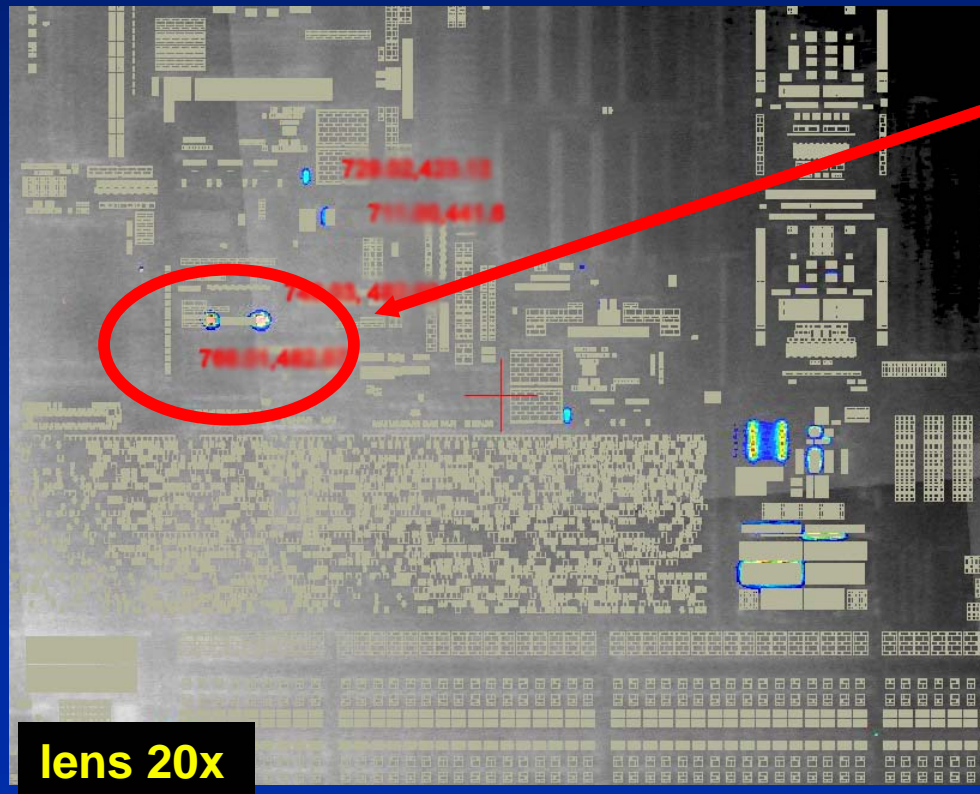
EMMI spots
(design bug)

1. Layout overlay
2. Determination of spot locations
3. Determination of net/transistor

→ 2 EMMI spots are correlated to „Dummy buffer short“

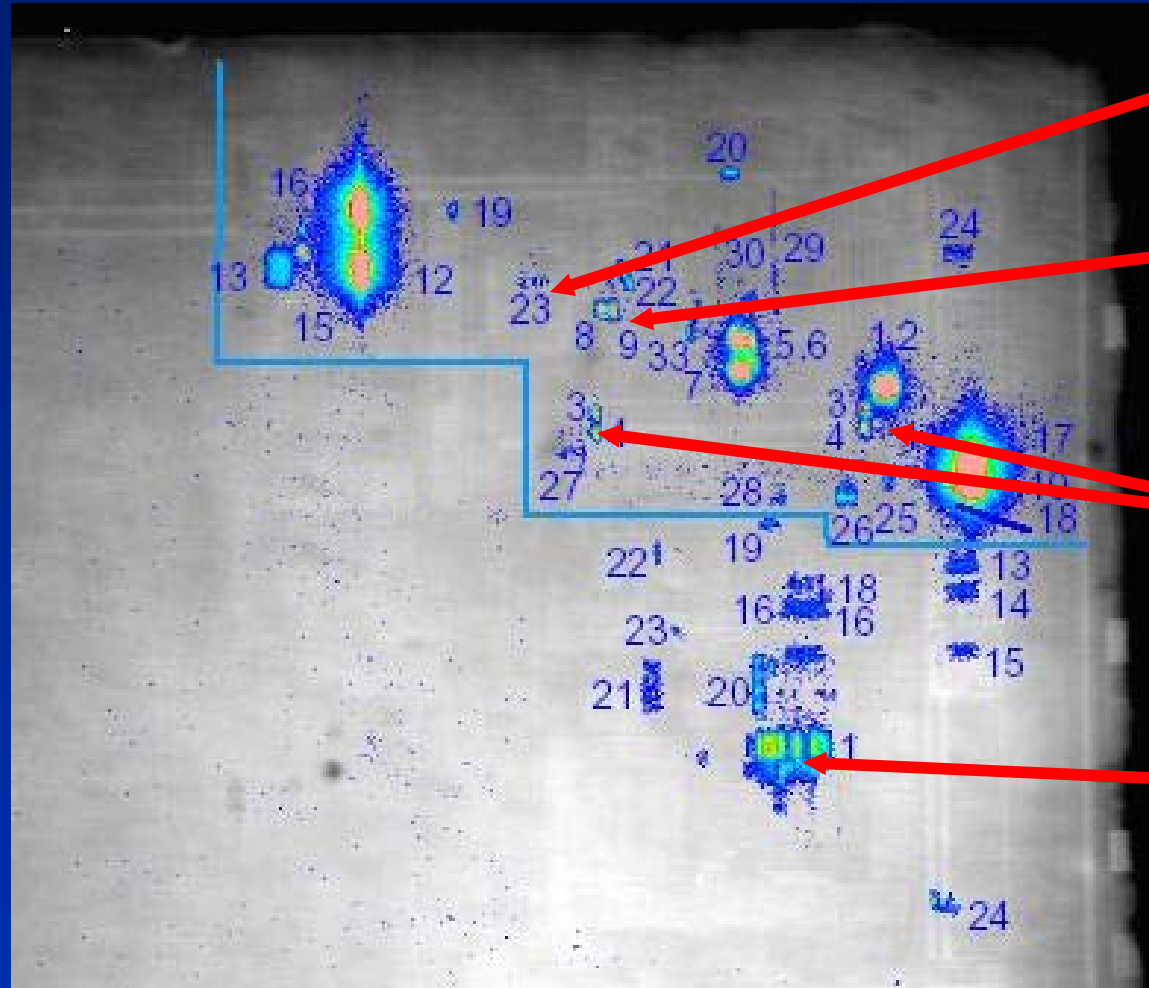
Power down issue (23)

Dummy buffer short (8,9)

Short between supplies (3,4)

PLL issue (1)

57 spots are classified

→ Most spots are due to normal functional activity

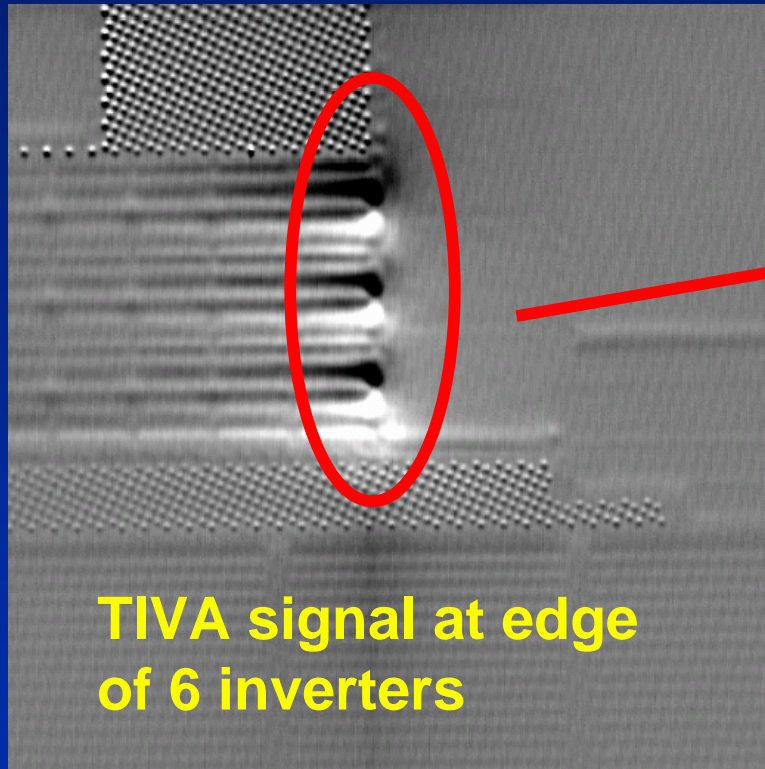
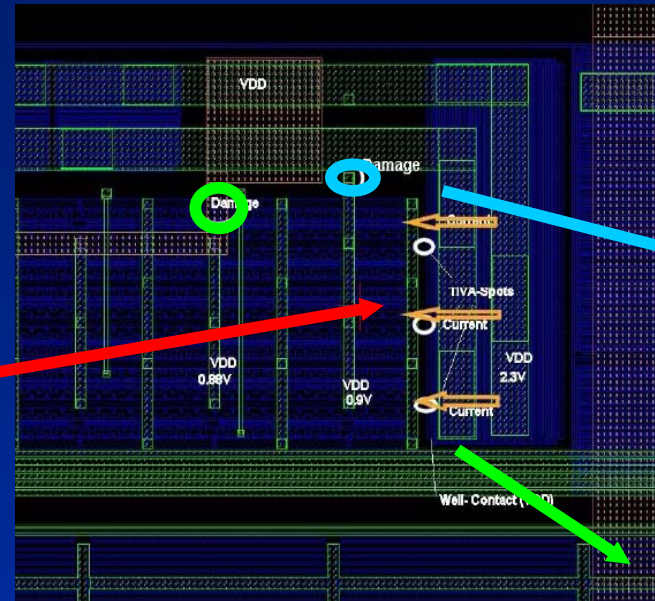
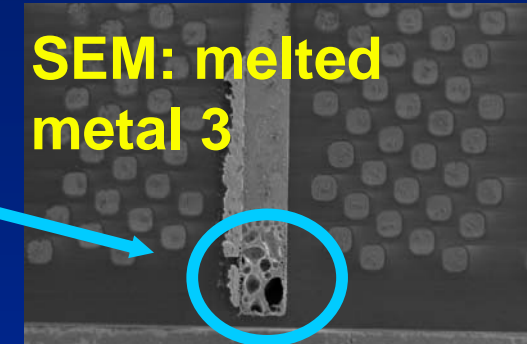
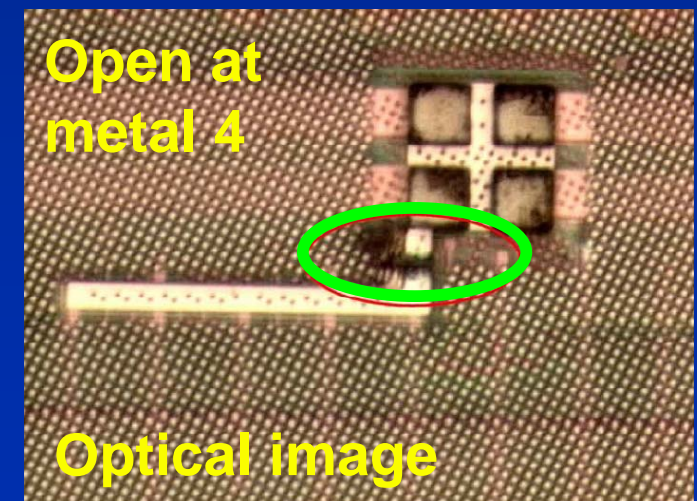
Case study 2: Increased current consumption after HTOL/testing

- 130 nm technology
- TIVA at converter supply

→ Metal 4 feeding line of DCDC converter is too thin for 3.3V voltage spike (simulation)

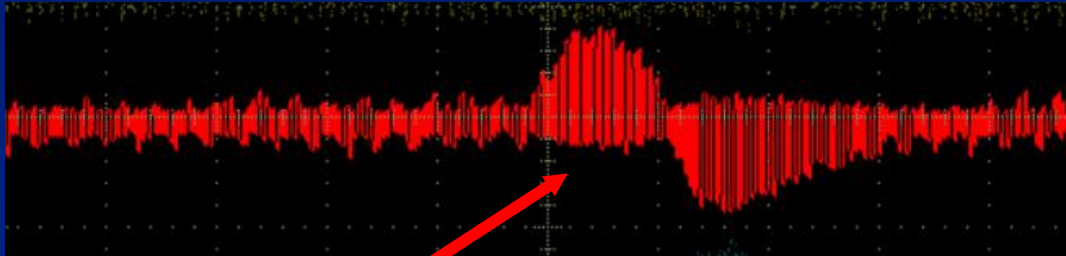
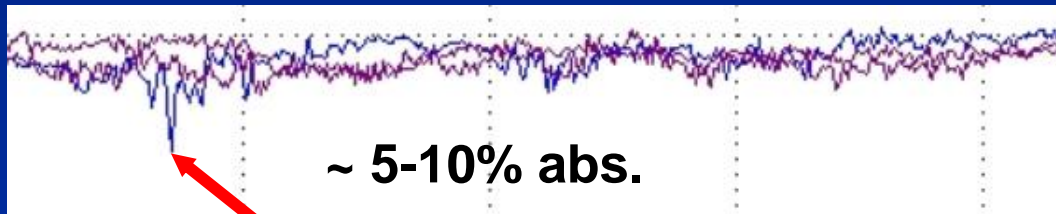
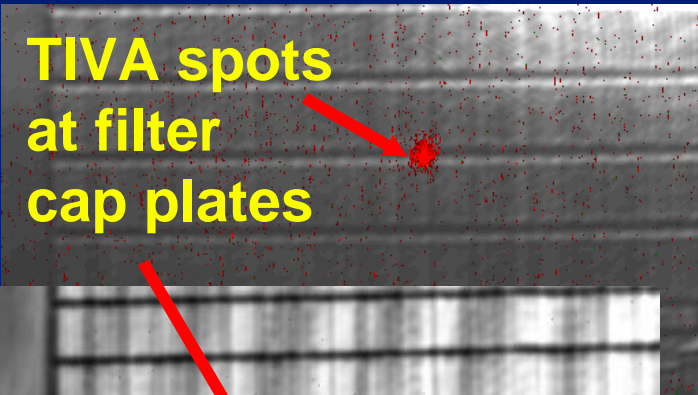
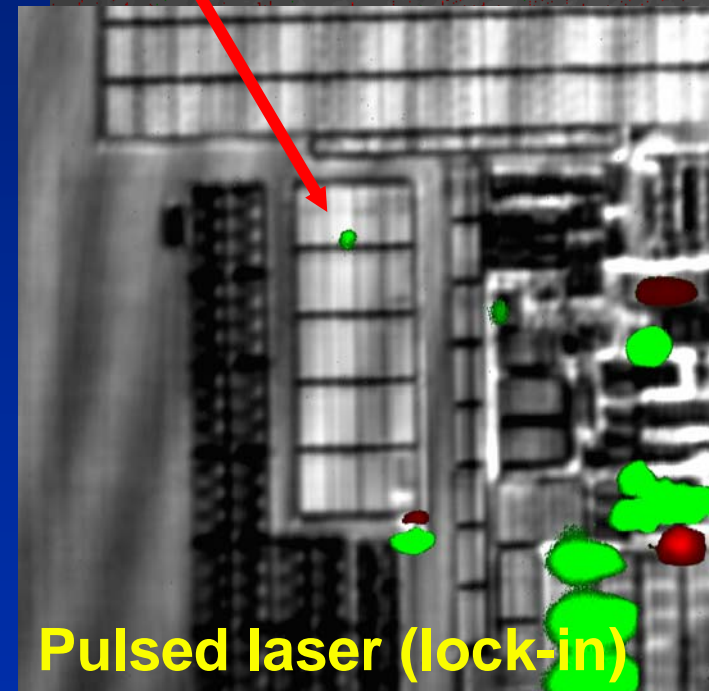
Case study 3: Phase error at INC/DEC pulses of a pump

Glitch rate ~ seconds/minutes

Increased cap plate leakage + fluctuation

- At TIVA with DC testbus ring supply monitored
- No EMMI!

→ Circuit marginality at filter is localized

Corrective action: change of cap type at new design

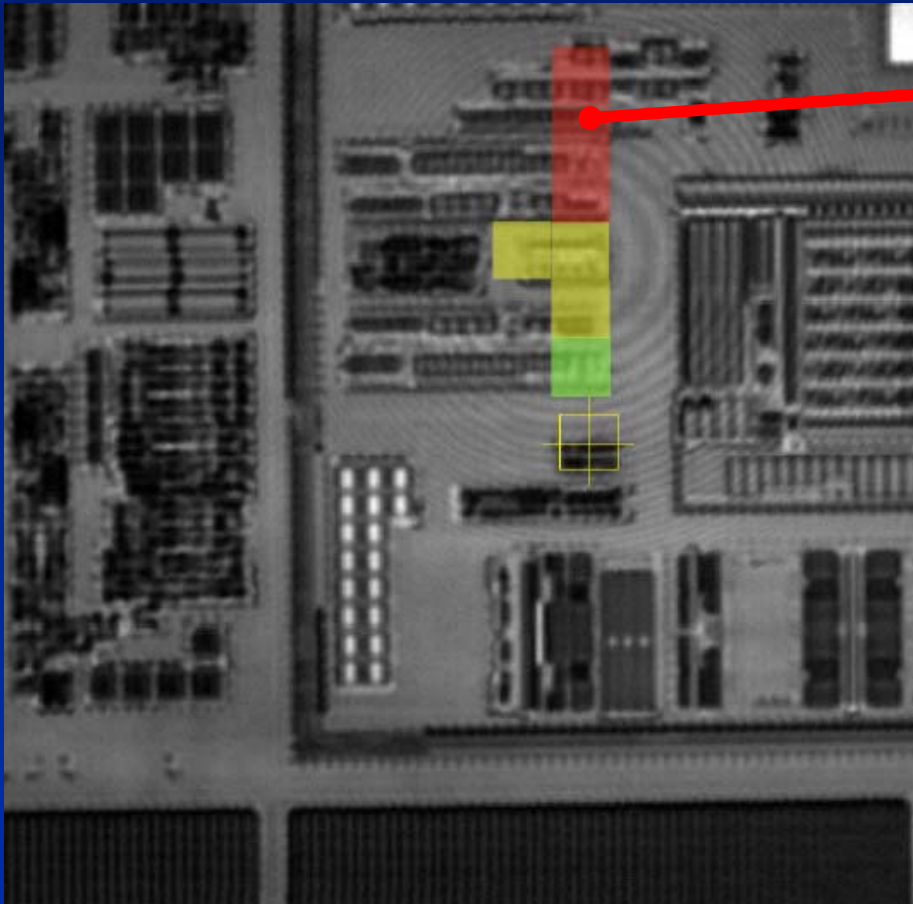
Case study 4: PLL loss of locking problem

**Incorrect well connection
(failure)**

- **130 nm technology**
- **Monitored signal correlates with PLL lock status**
- **Carrier injection with:
1064 nm Laser, 0.5% power**

→ Area with design bug is localized
