EDA Link Case Study

A Demonstration of the EDA Link Concept

The device was a NVIDIA 0.13 μ m graphics processor with 80M transistors

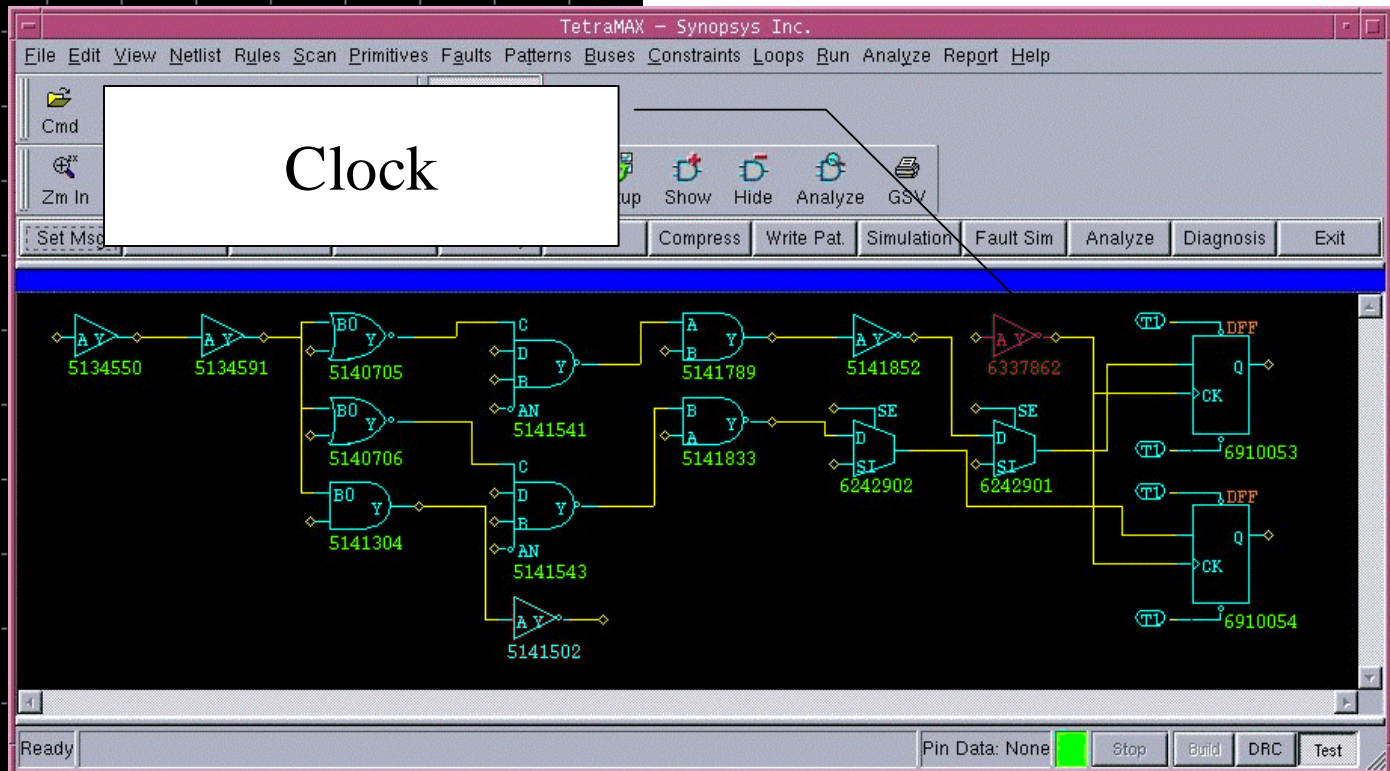
Probe the Clock to Establish a Reference

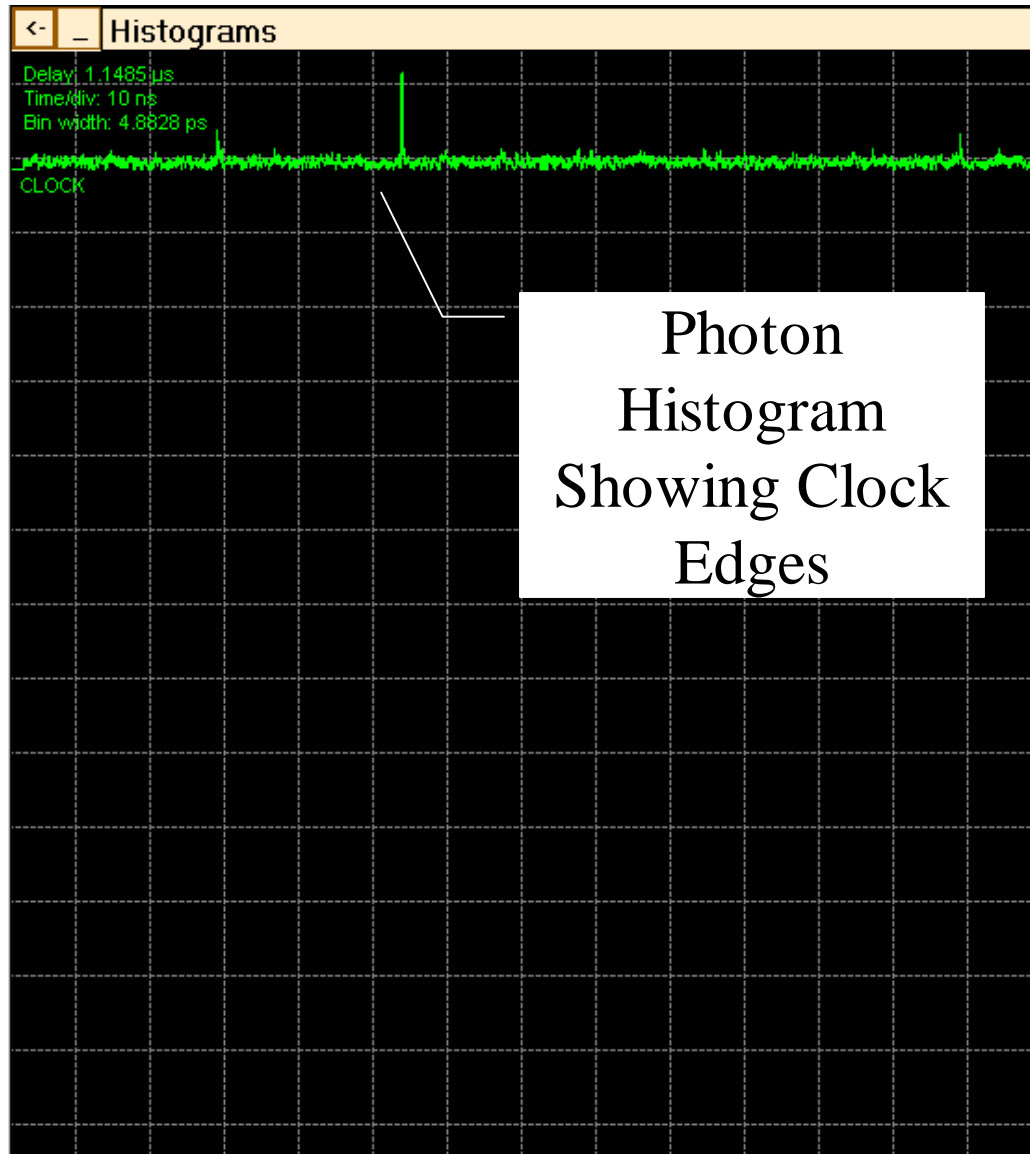
A Histogram is Obtained from the Prober

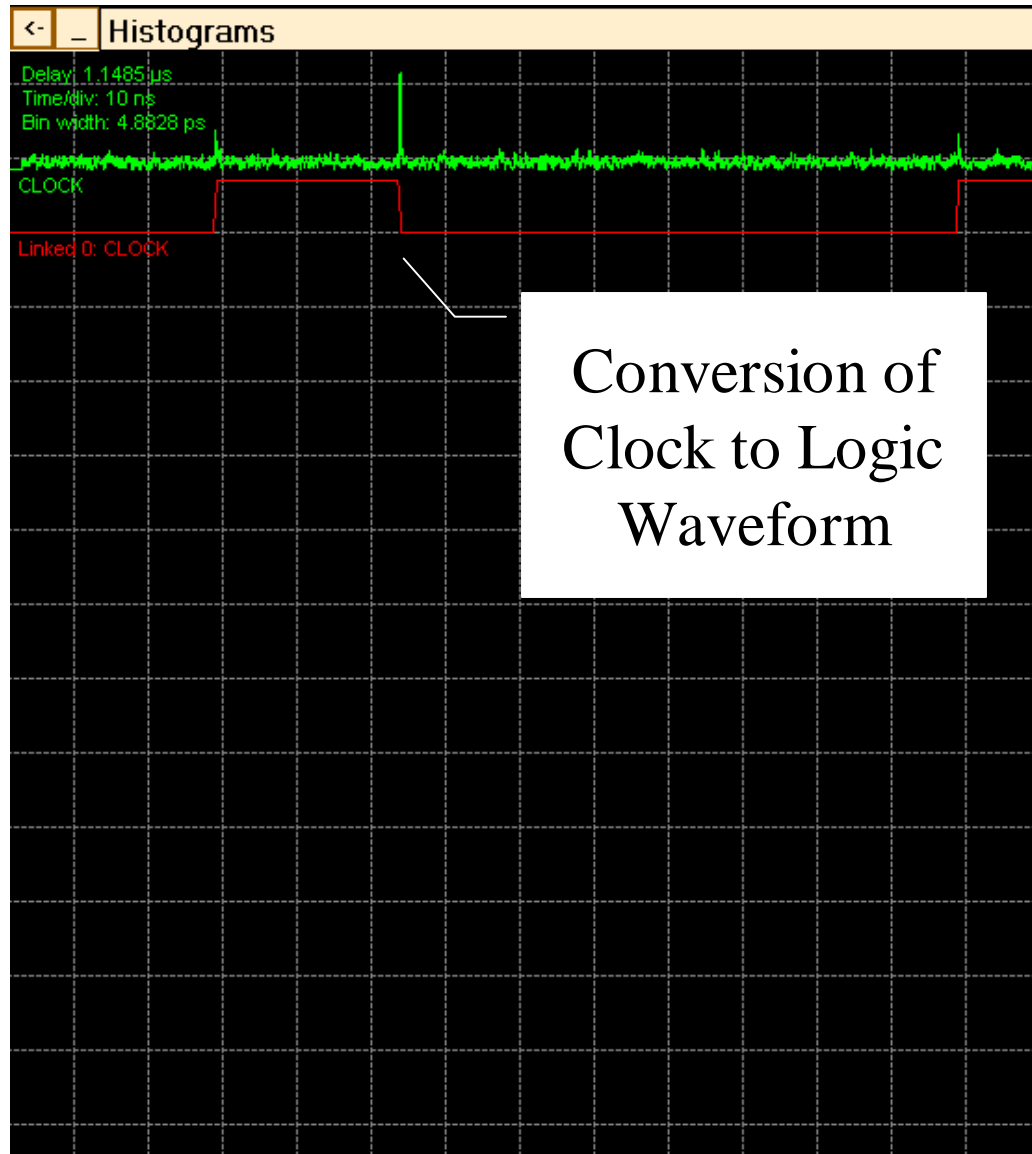
The Histogram is Converted to a Logic Waveform

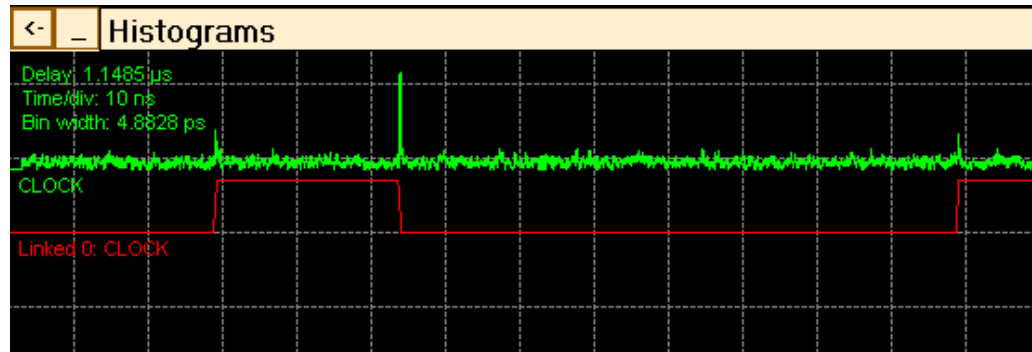
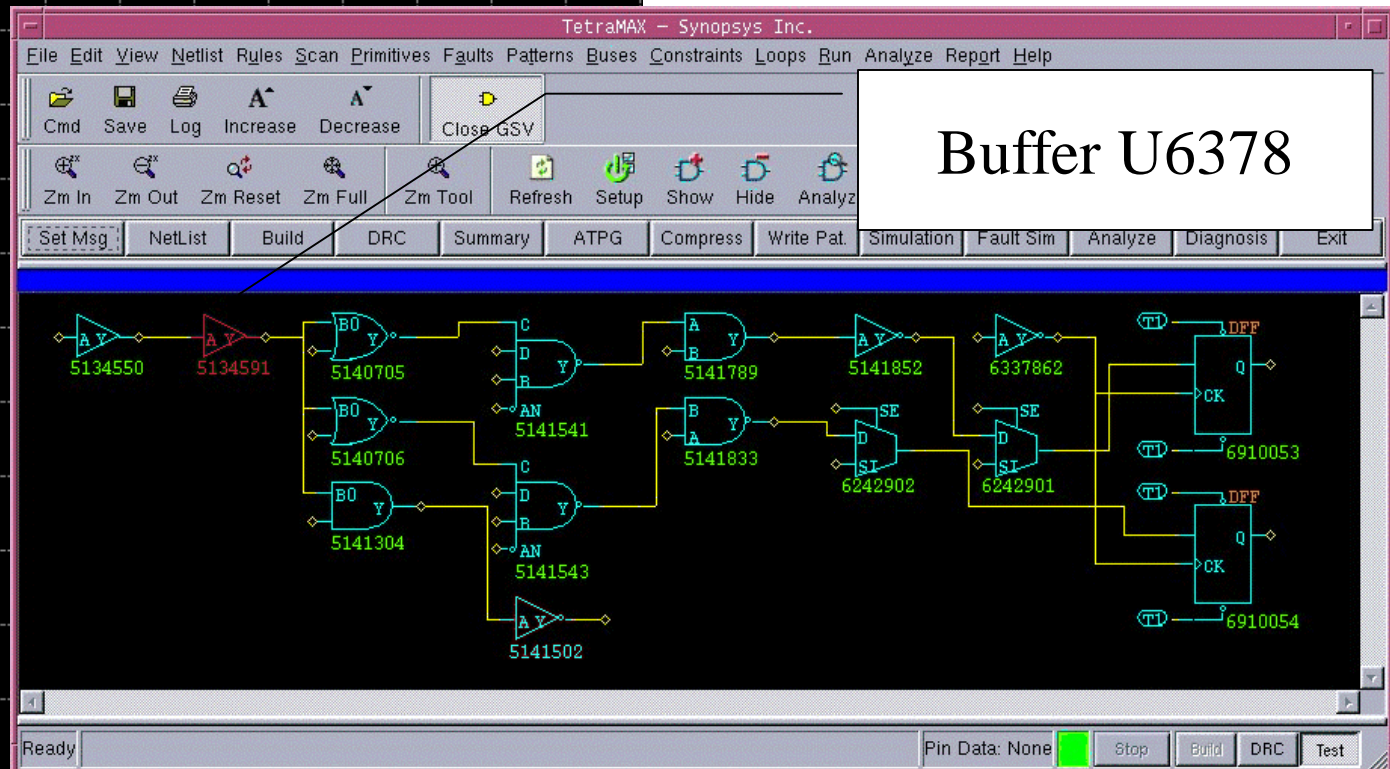
Next, Probe the Cell Indicated by ATPG

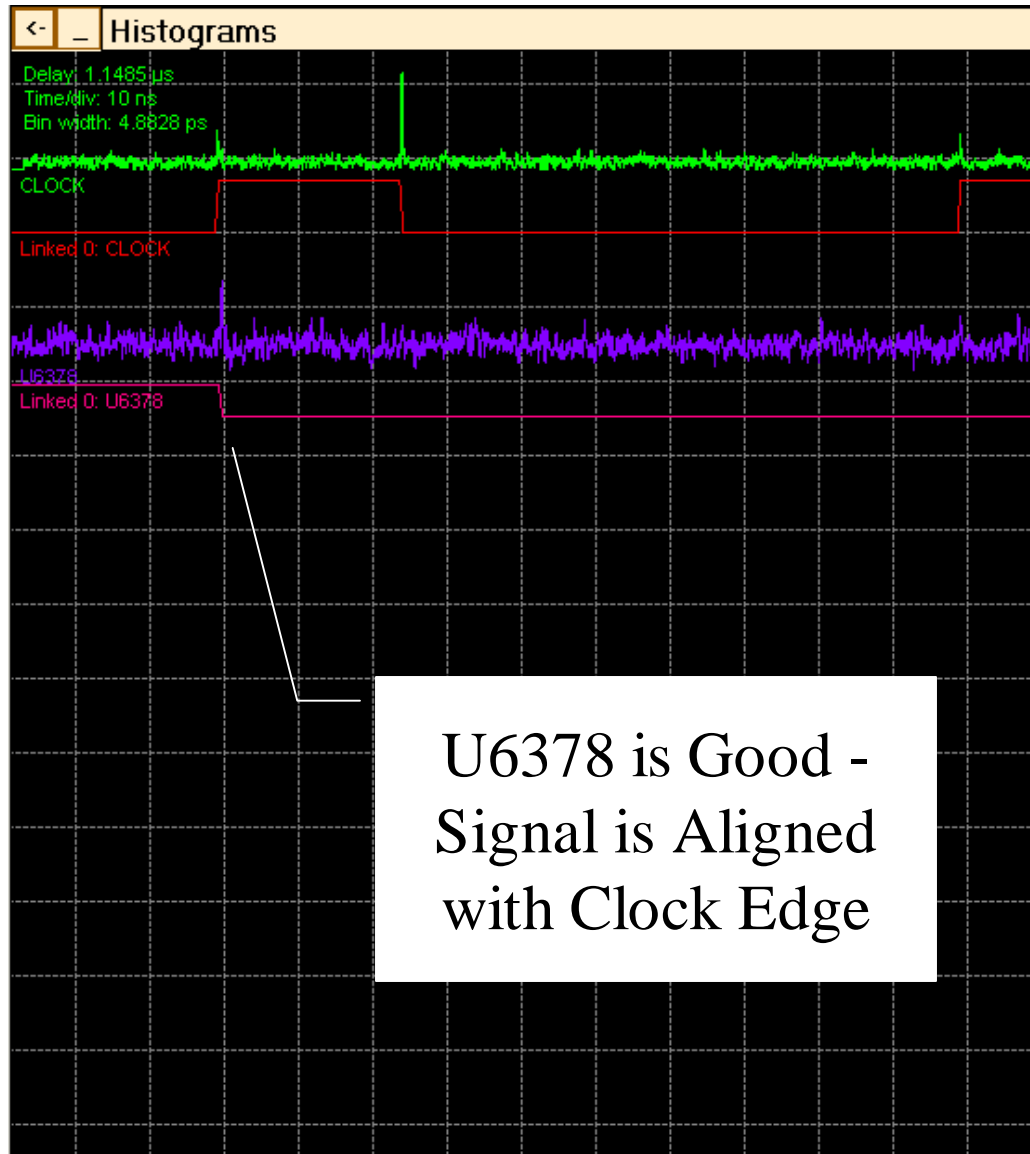
The Cell Indicated by ATPG is Not Failing

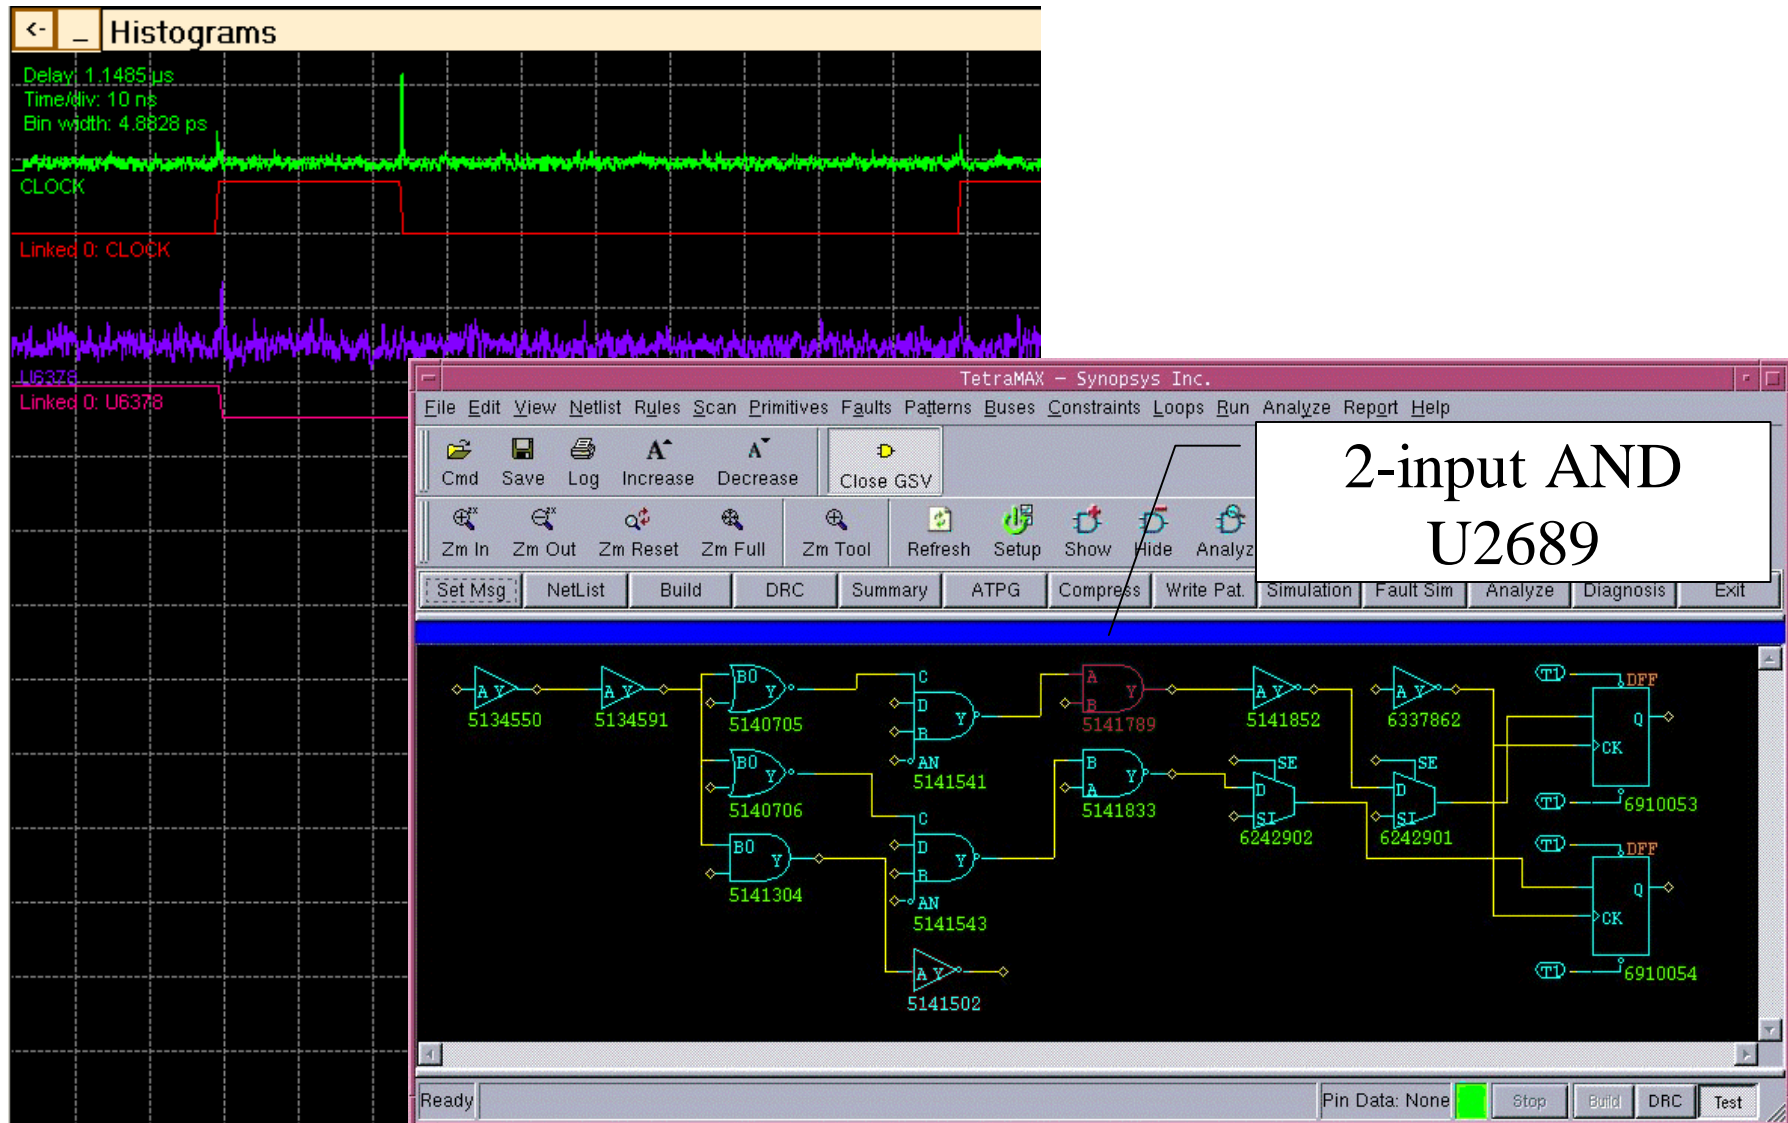
Begin Binary Search on Cell U2689

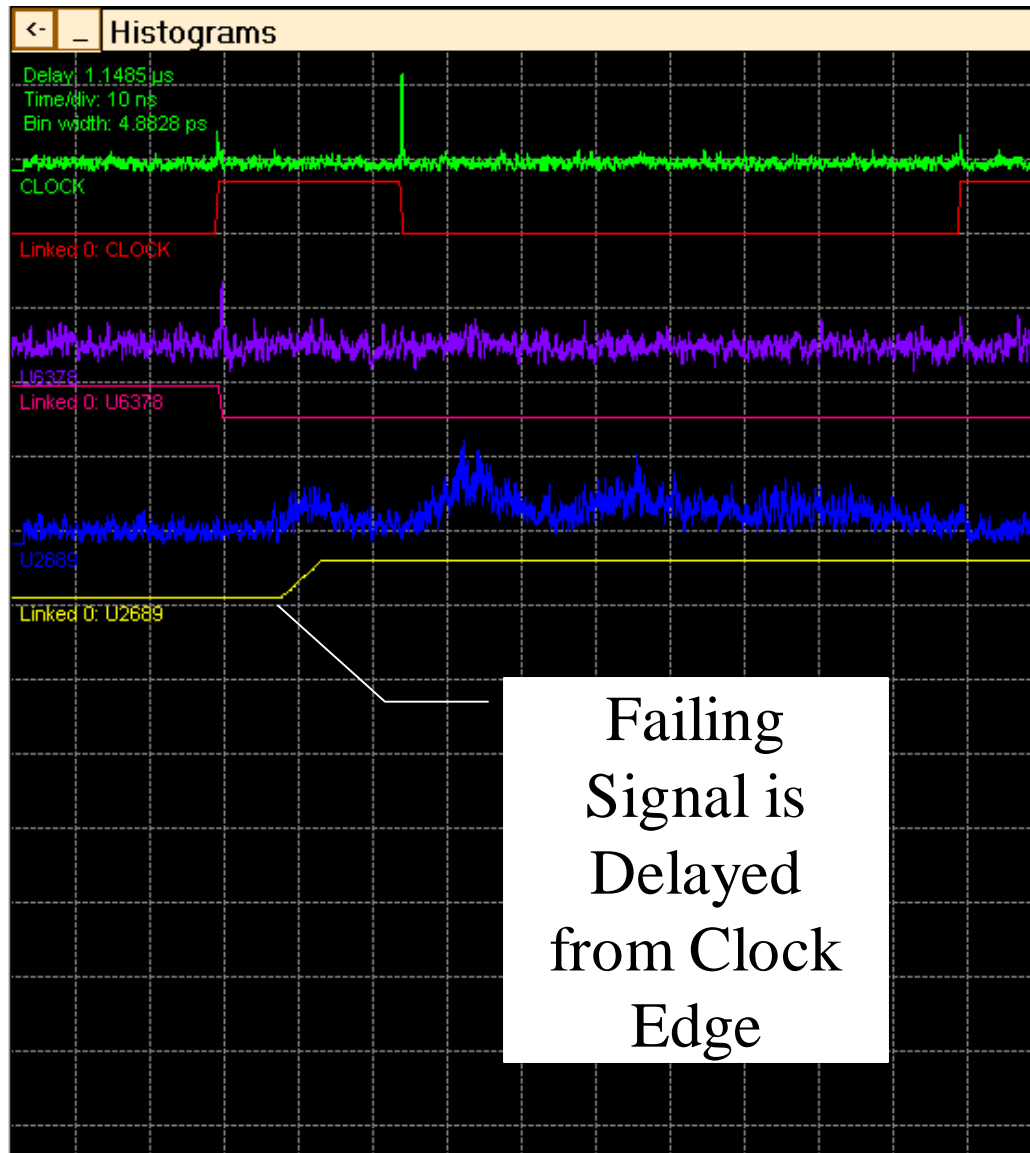
The Signal at Cell U2689 is Failing

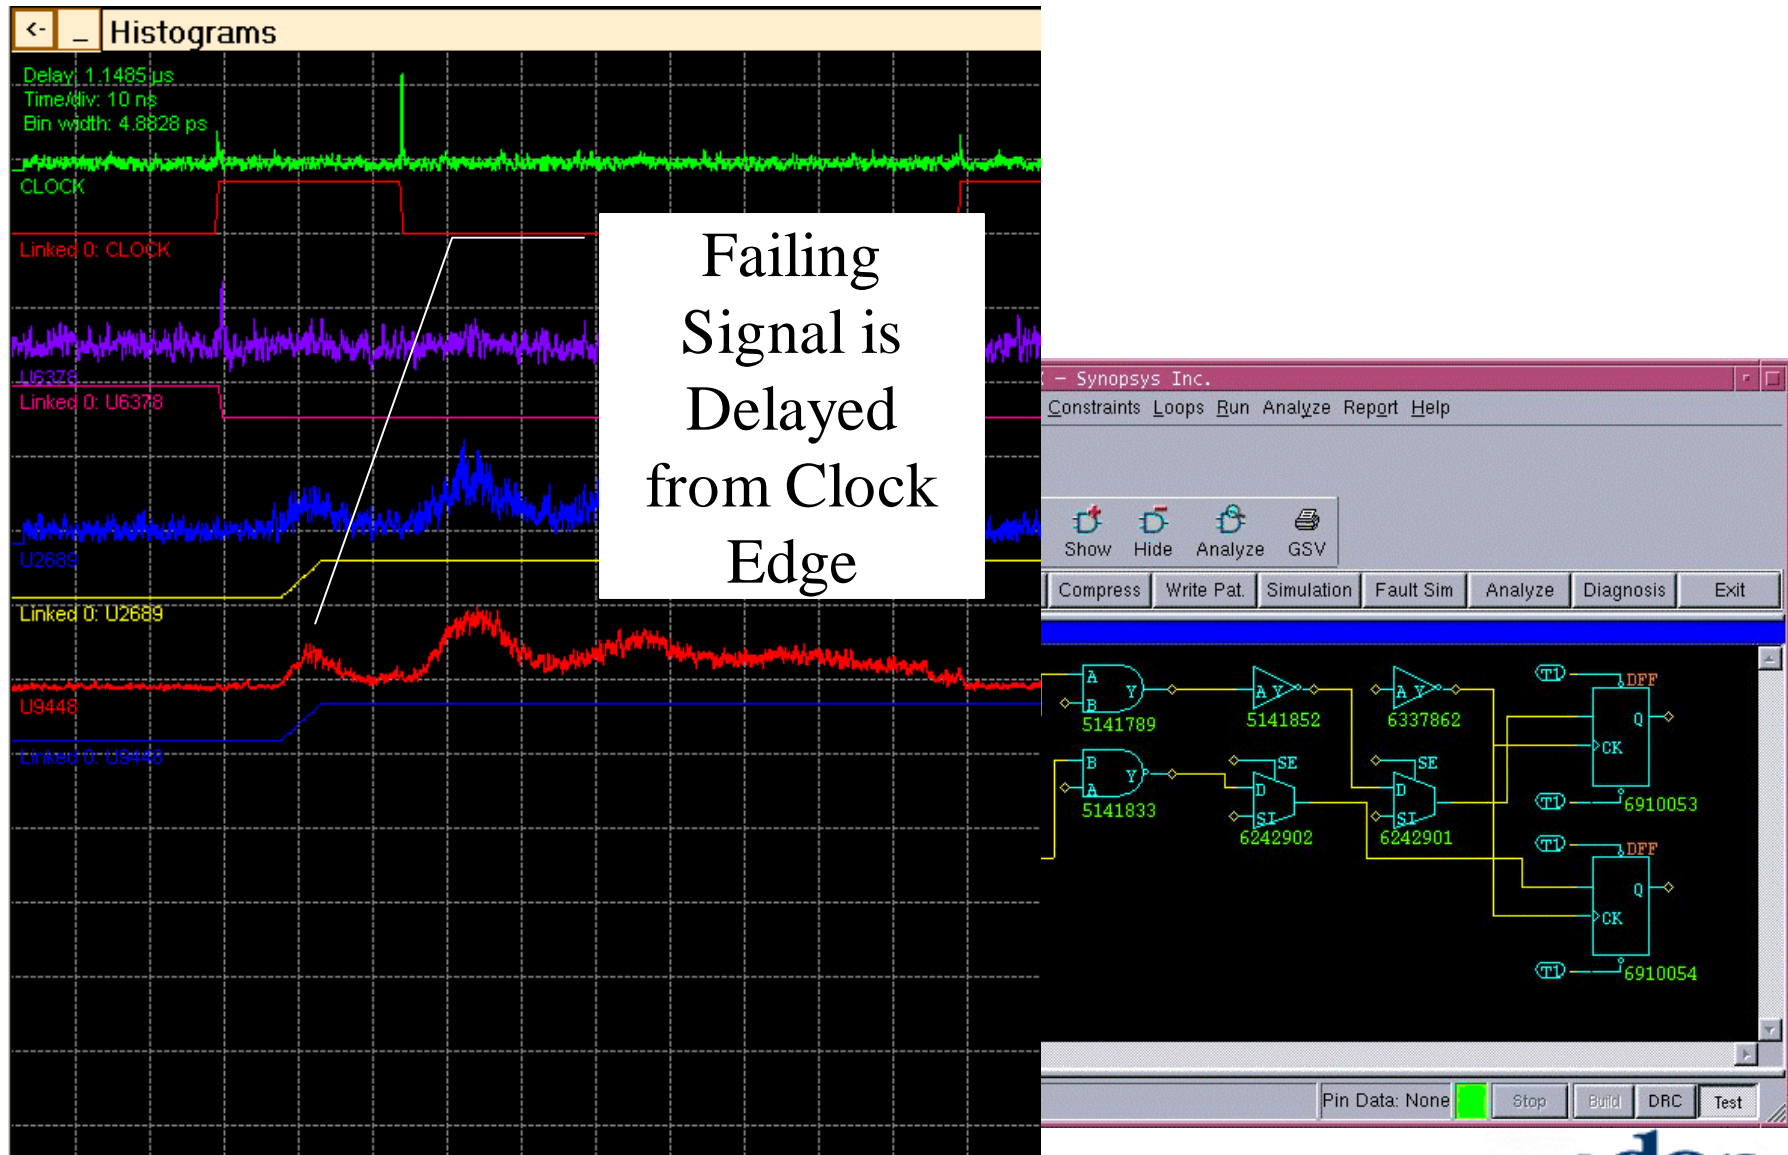
Continue Binary Search on Cell U9448

The image displays a screenshot of the TetraMAX software interface. On the left, a histogram window shows signal waveforms for CLOCK (green), U6378 (purple), U2689 (blue), and U2689 (yellow). The histogram parameters are: Delay: 1.1485 μs, Time/div: 10 ns, Bin width: 4.8828 ps. The main window shows a circuit diagram for a 2-input NOR gate U9448. The circuit includes several logic components: inverters (5134550, 5134591, 5141502), NOR gates (5140705, 5140706, 5141304), AND gates (5141541, 5141833), and SR flip-flops (6242902, 6242901). The output of the NOR gate is connected to the D input of the SR flip-flops. The SR flip-flops are connected to the CK and Q inputs of the DFF flip-flops (6910053, 6910054). A text box in the center of the circuit diagram reads "2-input NOR U9448". The TetraMAX window title is "TetraMAX - Synopsys Inc." and the status bar at the bottom shows "Ready" and "Pin Data: None".

The Signal at Cell U9448 is also Failing

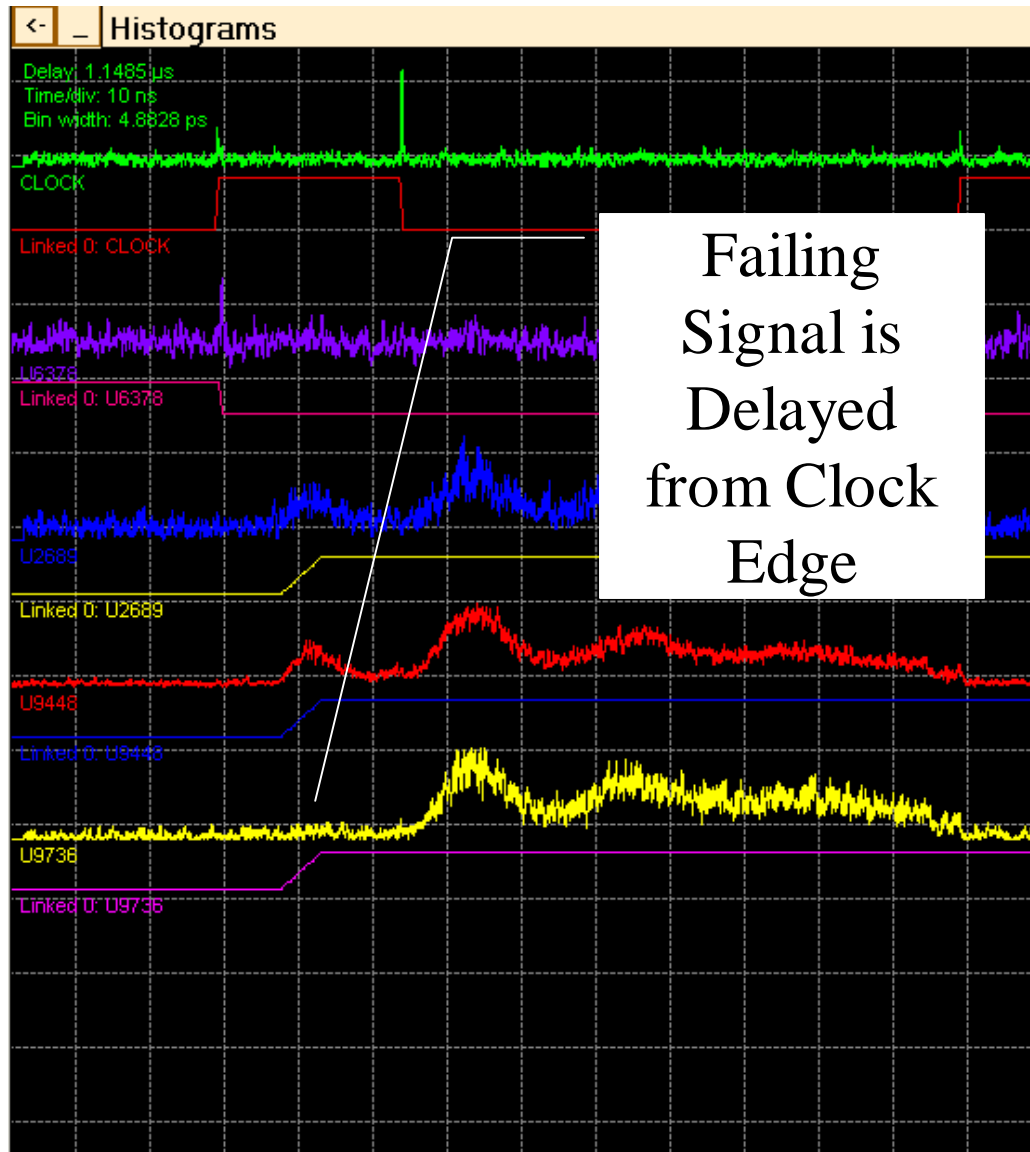
Both NOR Gates Show a Similar Failure

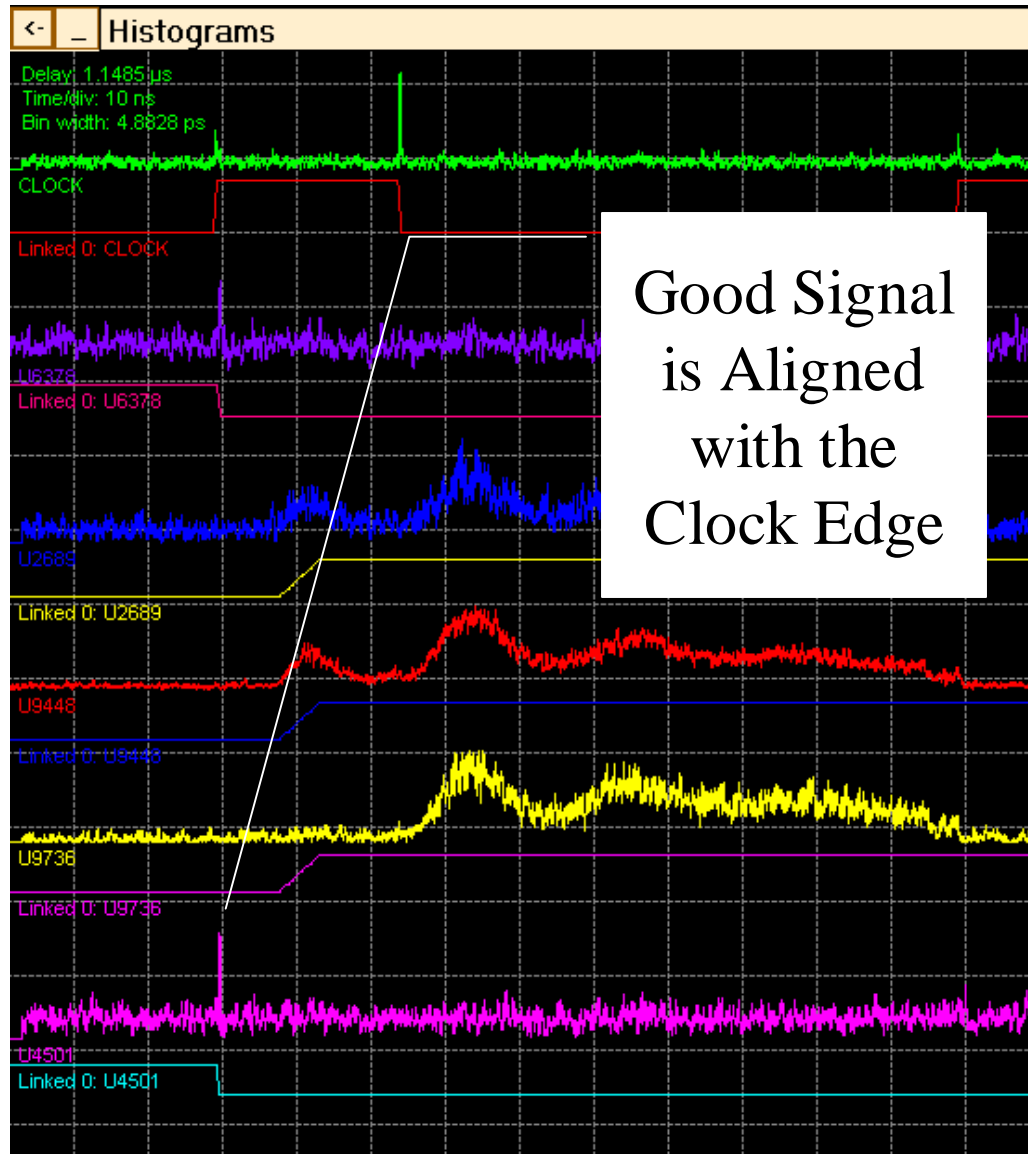
The Signal at the AND Gate is Good
