EUFANET

EUropean Failure Analysis Network

**Failure Diagnosis by Optical
Techniques Combined to Layout
Localization Software
for Wafer Yield Improvement**

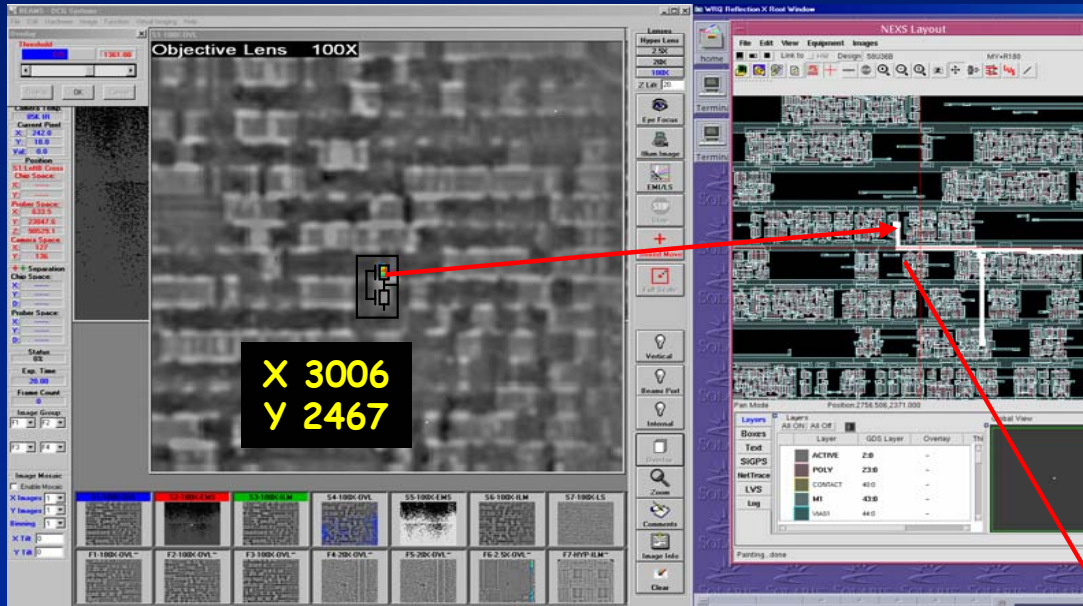
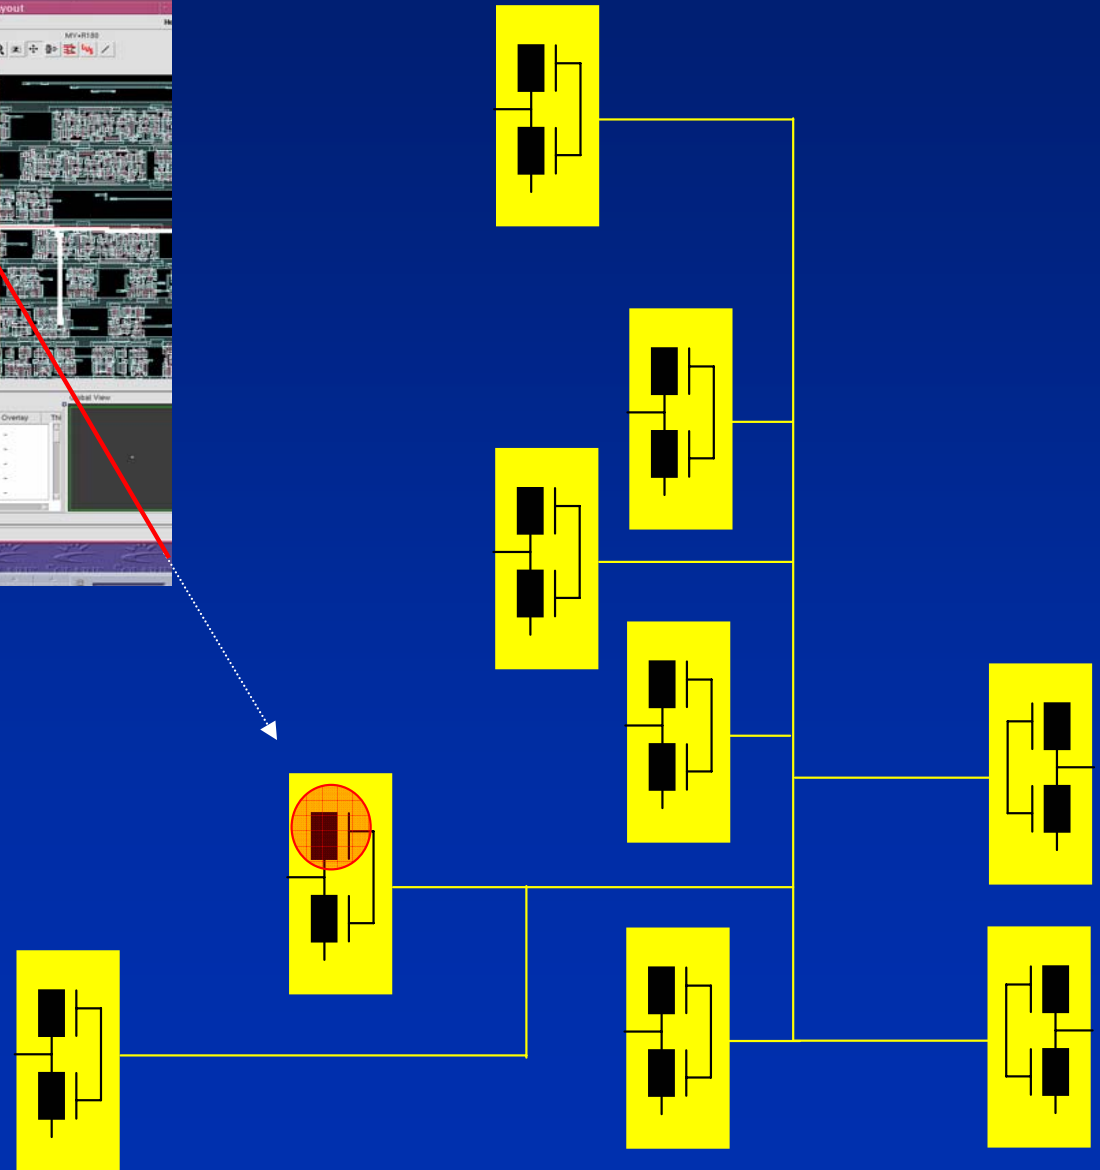
Emissive sites are up to few hundred micrometers away each other

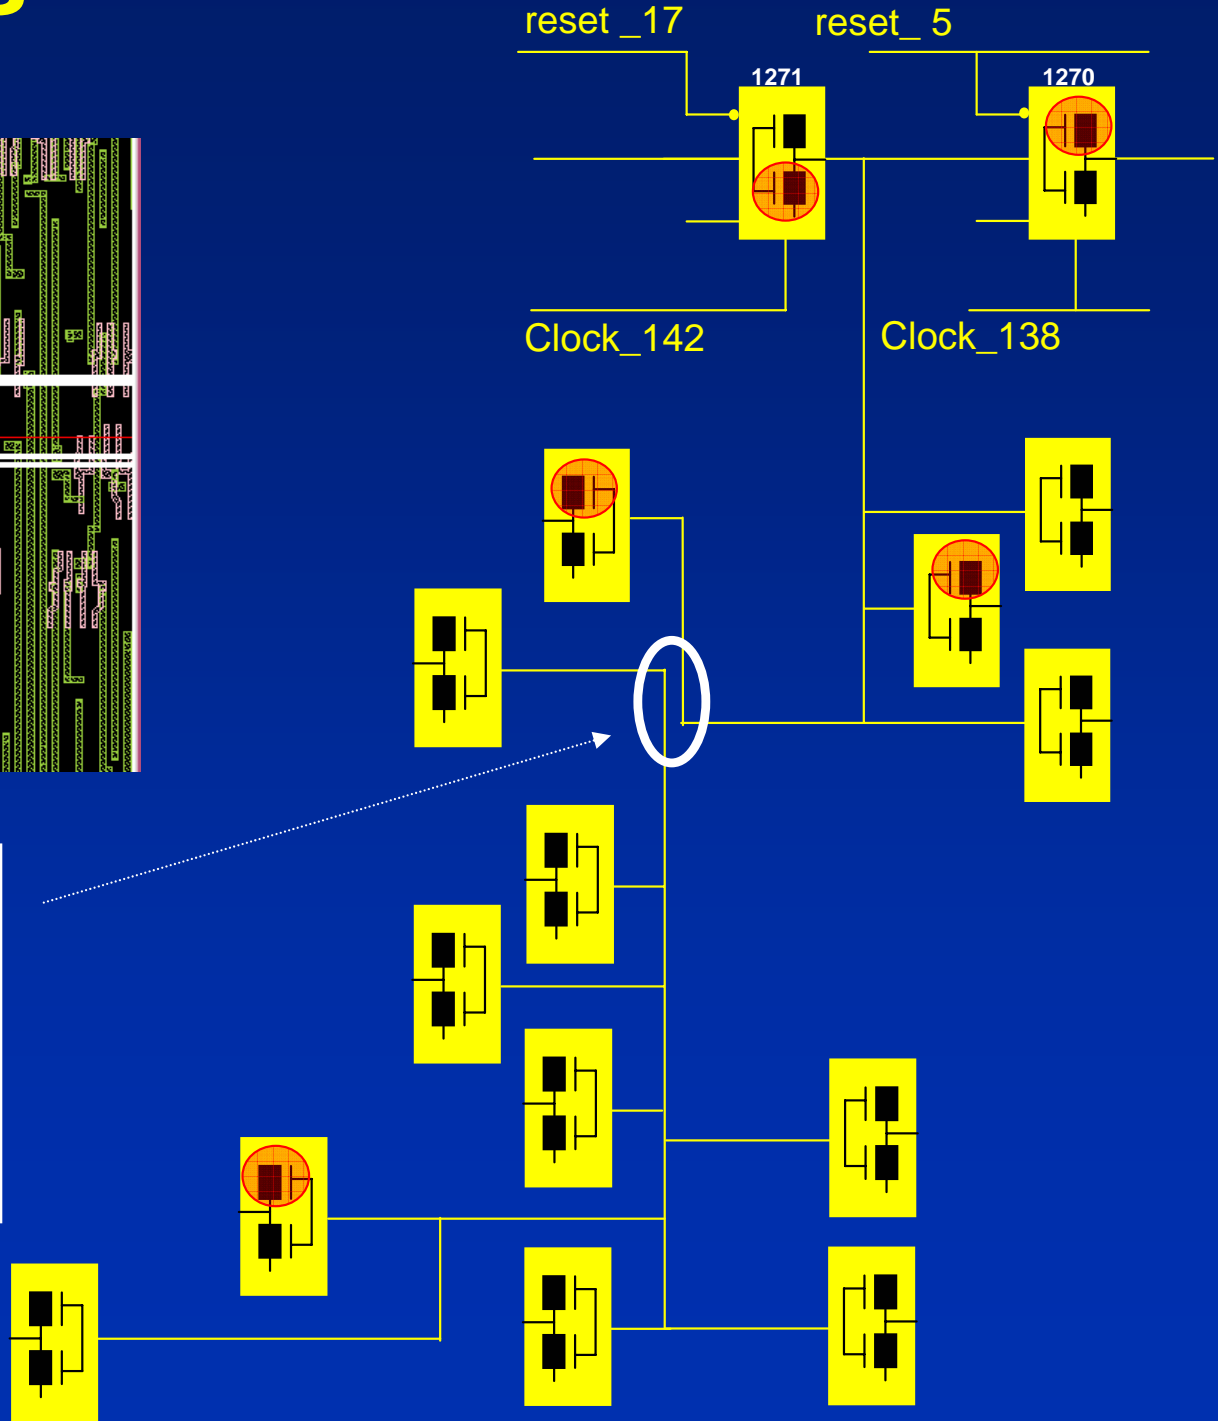
Layout localization software allows to identify a specific critical area at Metal 2 and Metal 3 level
➔ “net trace” capability

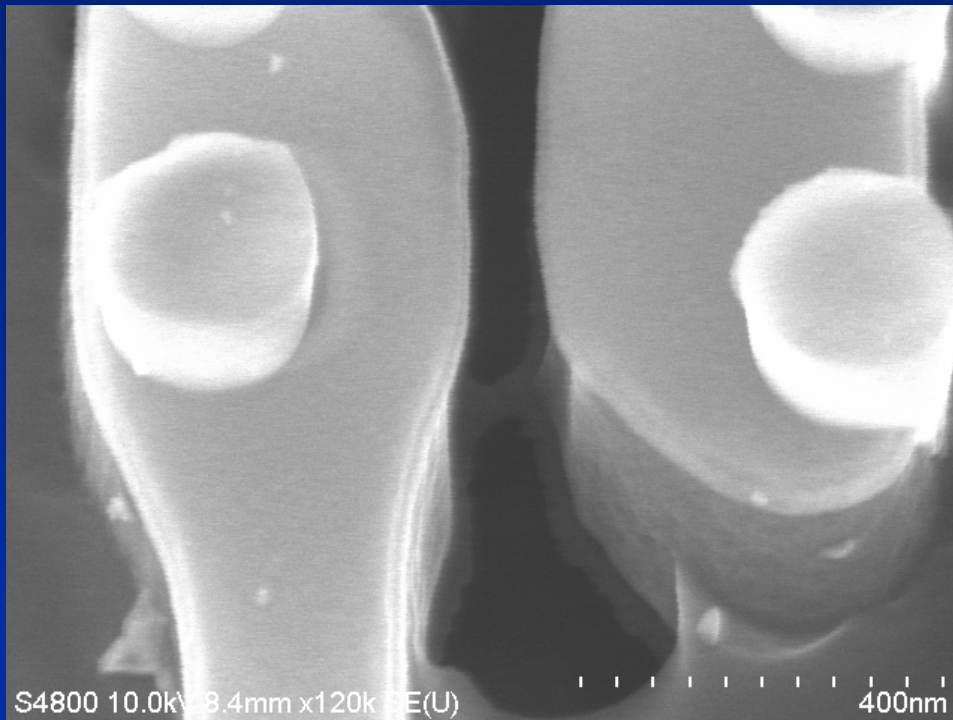
Metal 2 level

Metal 2 Barrier short due to side to side landing pad structure
