# ***Analog IC sample prep***

## Case study of failing device using BCB/Cu technology

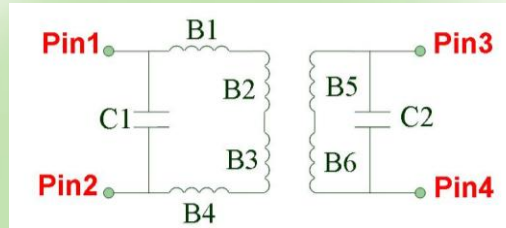
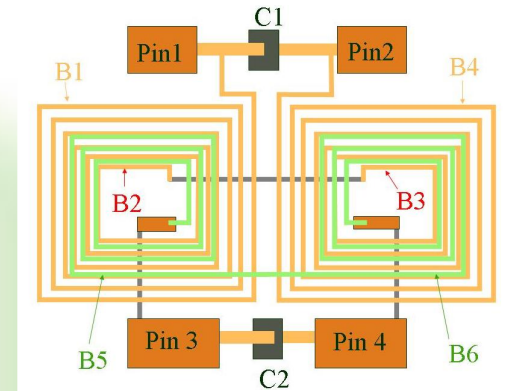
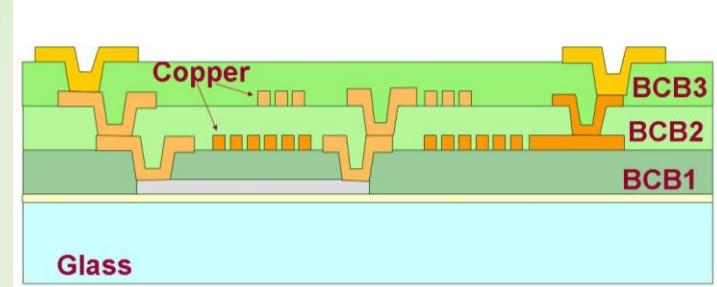
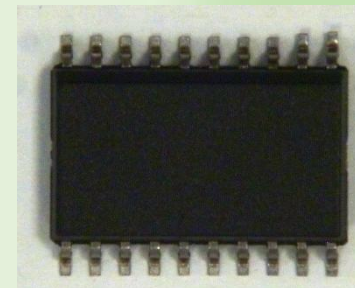
- The component is an RF product used in the transceiver module of cellular phones, and is made up of inductors and capacitors.
- The component contains:
  - A glass substrate
  - 2 copper metallization layers
  - Several dielectric layers composed of BCB, an organic isolator
- The component is encapsulated in an SO20 type package made of plastic molding compound

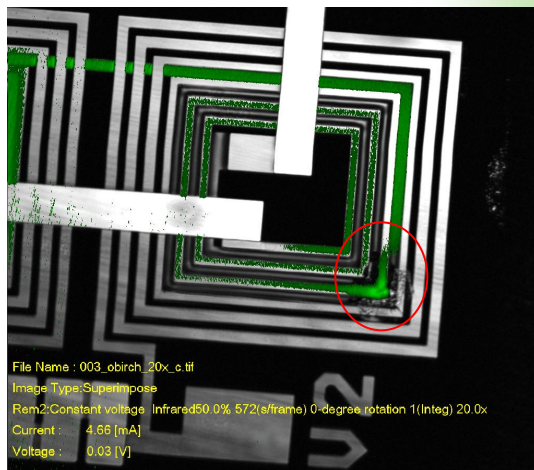
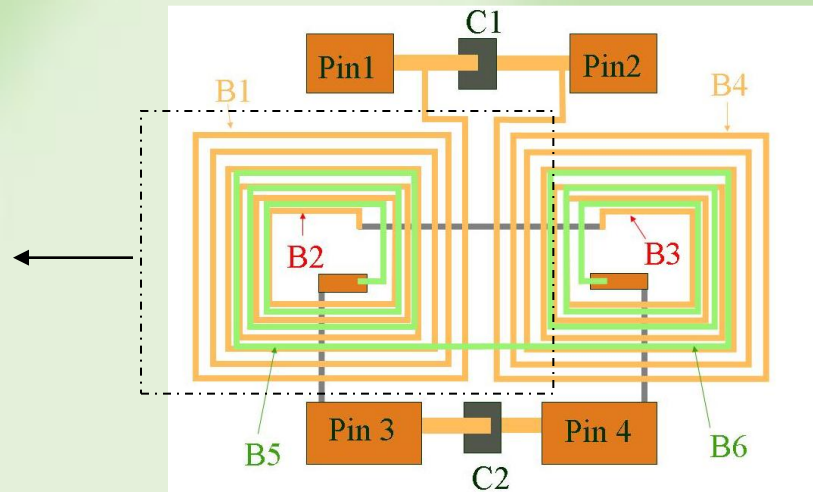
- Backside polishing, followed by OBIRCh, which detected low ohmic short
- To determine cause of failure would be necessary to access the frontside of the die without damaging the BCB dielectric layers or the Cu lines

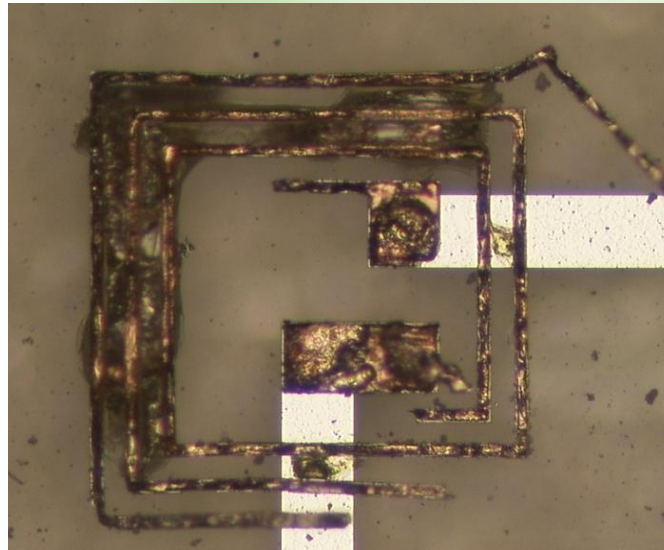
- Standard Method:
  - Access front side of the die by wet chemical etch of the plastic molding compound
- Result:
  - Molding compound removed, but the BCB layers have been etched as well and the copper lines have been detached and/or etched away

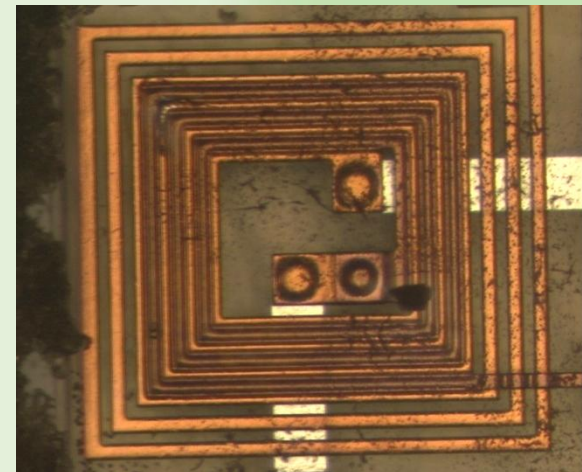
- Results:
  - The plastic molding compound has been removed
  - BCB layers and Cu lines still intact

Laser pre-decapsulation

Plasma RIE assisted by (CO2) filler blast

Gaz	Puissance	Pression
Prog 1 <sup>a</sup>	190cm <sup>3</sup> CF <sub>4</sub> ; 495 cm <sup>3</sup> O <sub>2</sub>	200W	4350mT
Prog 2 <sup>a</sup>	47 cm <sup>3</sup> CF <sub>4</sub> ; 495 cm <sup>3</sup> O <sub>2</sub>	200W	4350mT

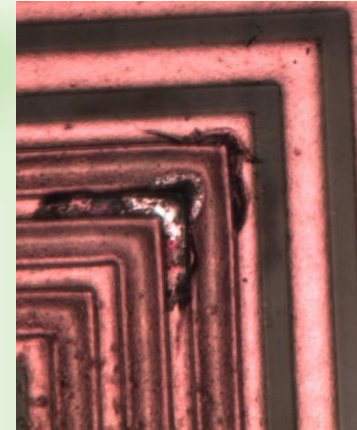
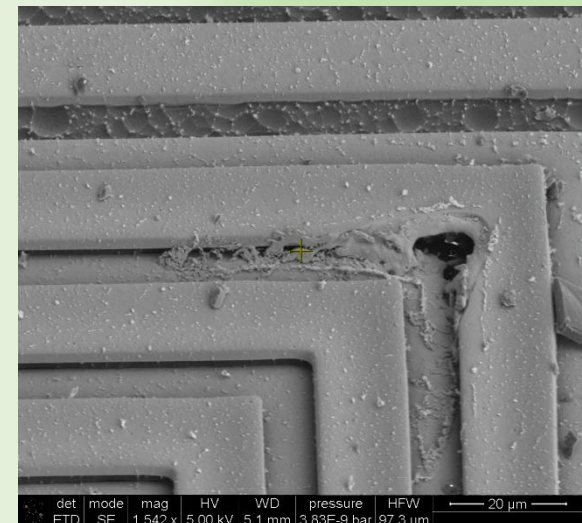
- Conclusion after decapsulation:
  - The defect was found not to be at the surface of the die, but between two metal layers
  - Defect found after further RIE plasma etch of BCB layers (2 Cu lines fused by heating).
- Conclusions on methodology:
  - Standard method not applicable due to introduction of new materials
  - Laser + plasma etch has made it possible to access this type of device from front side without damage
