HAMAMATSU THEMOS Mini Evaluation

WMM, C&P Failure Analysis / GNB Failure Analysis Lab EUFANET

Optical Localization Techniques Workshop

26 & 27/01/09

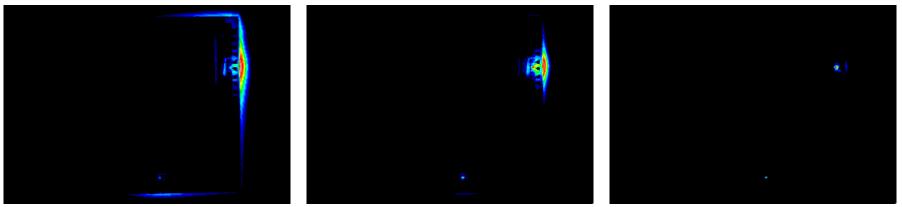
Result of changing power supply modulation frequency.

Conventional method: 40seconds

Thermal lock-in method: 1Hz

Thermal lock-in method: 20Hz

The dispersion of heat is suppressed by raising the modulation frequency, and the identification of the thermal source points is facilitated.

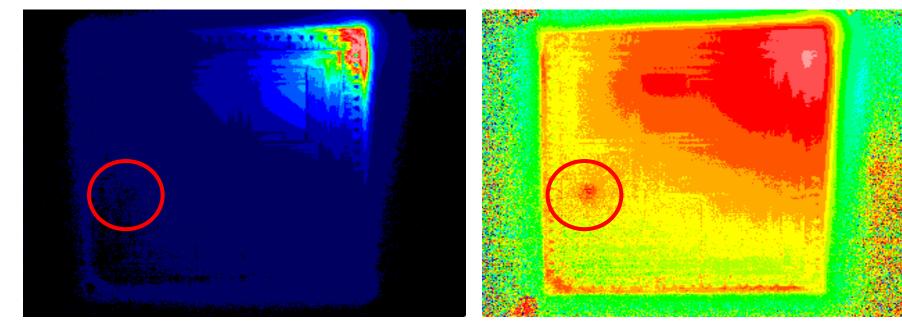
Thermal lock-in : Amplitude

Thermal lock-in : Phase

Week thermal emission was not able to be detected in the amplitude image, but it was able to be detected from the phase image.

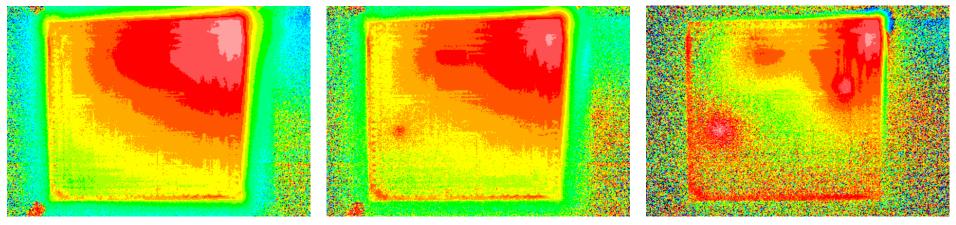
Thermal lock-in : phase image

1Hz

2Hz

10Hz

The heat response characteristic can be recognized by changing the frequency of thermal lock-in.

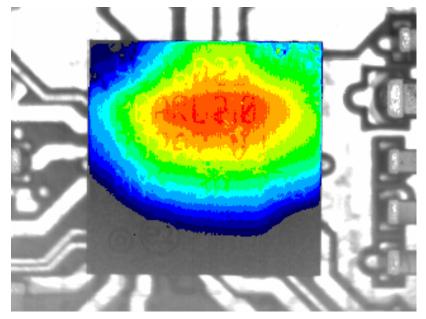
Sample 2: unit is stopped, cooling phase

- Thermal mapping acquisition is done with an application board.
- Package is not decapsulated.
- Feedback from our internal requestor:
- There is no thermal camera matching our needs, temperature value measurement with an accuracy of +/-5°C.
- Option available Q2/09

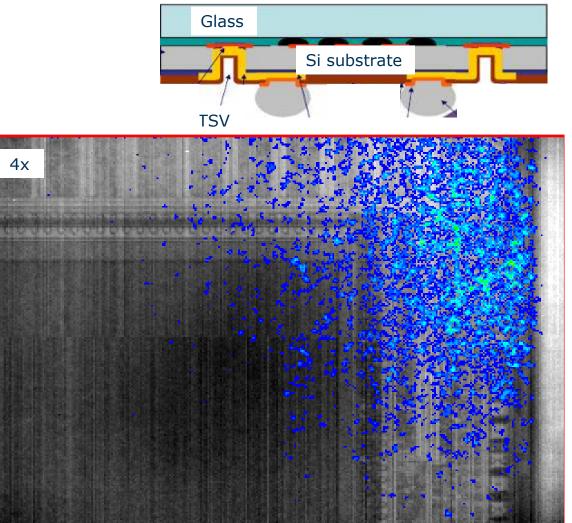
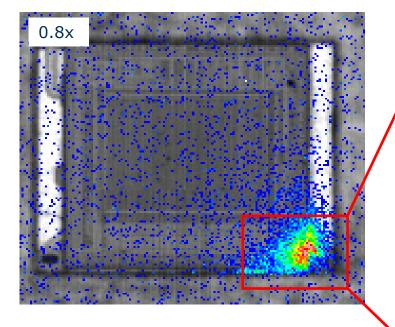
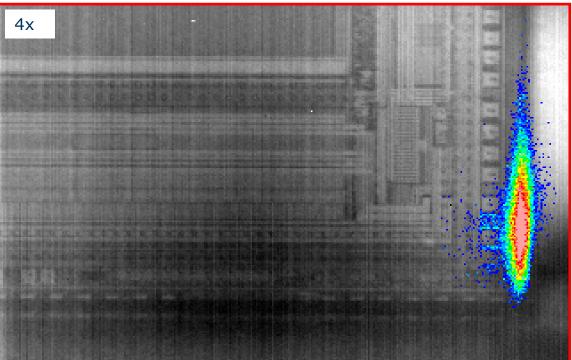
- Leakage on Vana 1 mA vs 1.5 µA for a Ref.
- Obirch analysis done with no abnormal signature.
- Thermal analysis shows hot spots at the bottom right corner of the die close to Vana pad.
- \rightarrow Damages are seen on die edge probably due to a bad sawing.

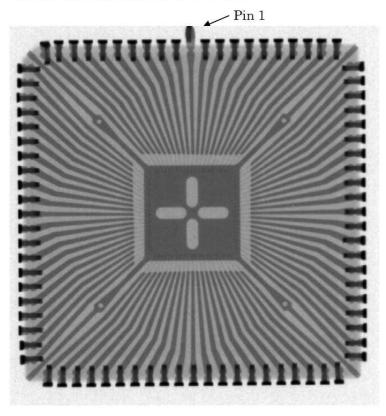
1.1.2 X ray image (Front side E=80keV)

In the X-ray image, we can not see Si, but can see bonding wires. Thermal signal is observed around bonding wire area, which leads the guess that there may be something wrong under Si. Thermal signal is not round but looks like having a tail toward right direction

Open the package from backside for further investigation.

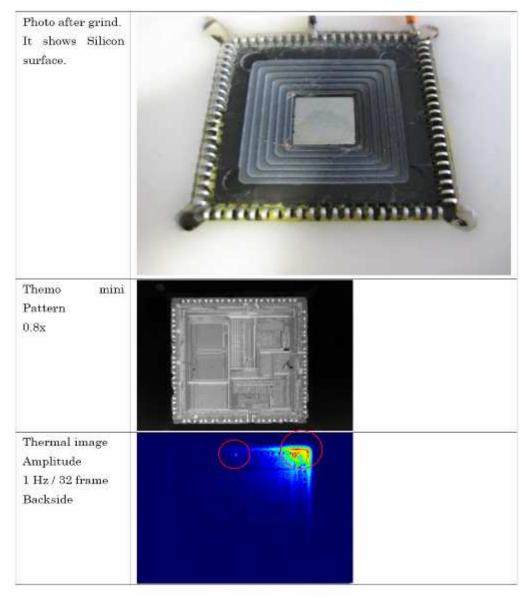
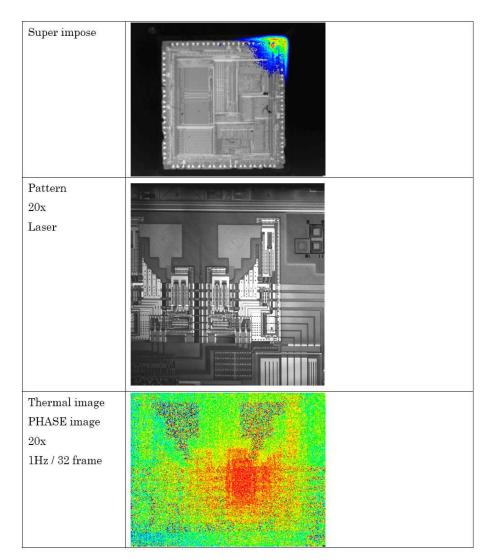
Thermal signal is observed around bonding part on Si. There is another thermal signal observed at left side of large one. We guess this small spot causes a tail in the signal we observed on the device surface.
