NXP : Dynamic Laser techniques

Application examples

Frank Zachariasse
EUFANET Workshop
Toulouse, January 2009

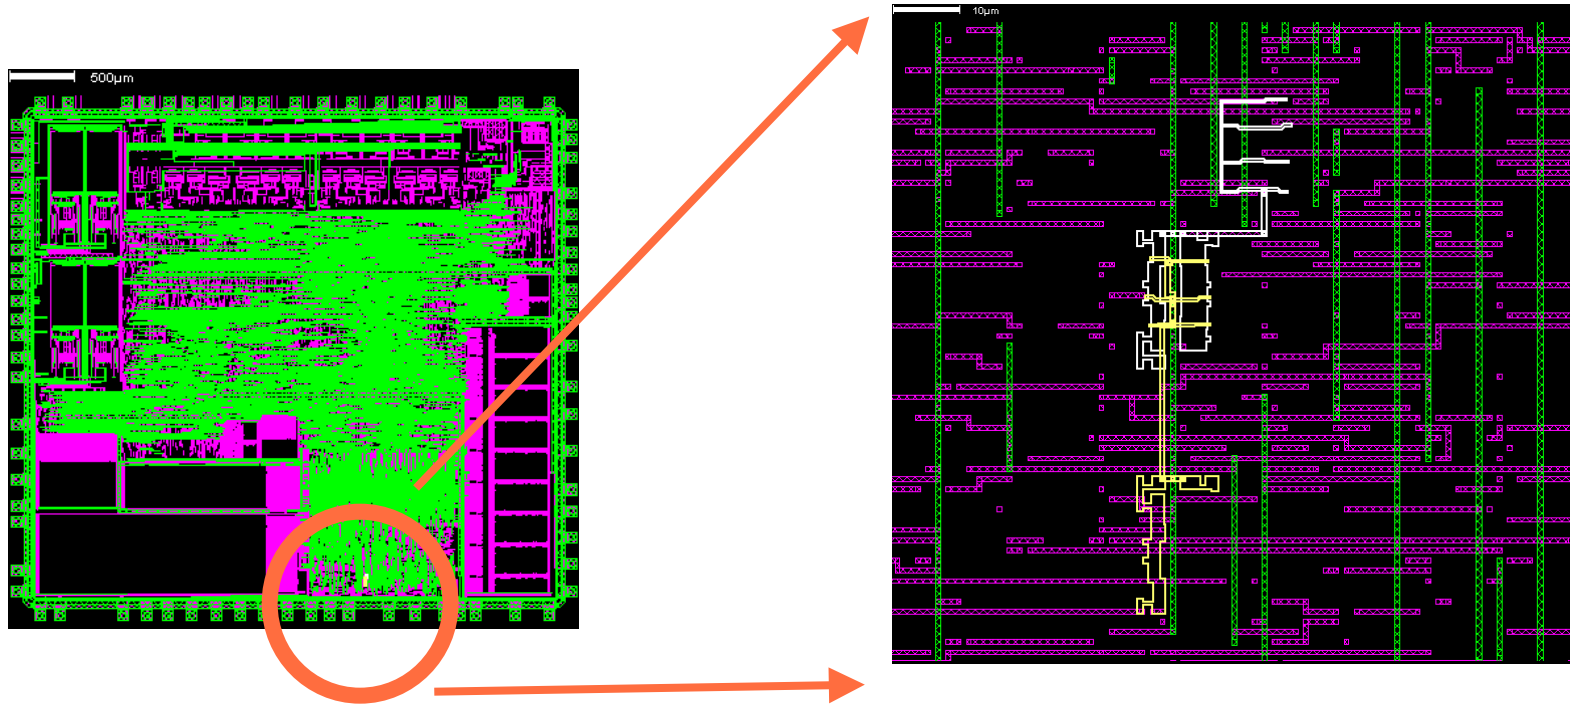
Customer return : DLS and FIB XS

- ▶ Audio DSP IC, 0.35 micron technology
- ▶ Customer description “Noise in CD mode”
- ▶ ATE Test shows Delay fault
- ▶ Software localization (using tester result) identifies 2 possible failing nets
- ▶ Therefore, need further localization to find exact fail site

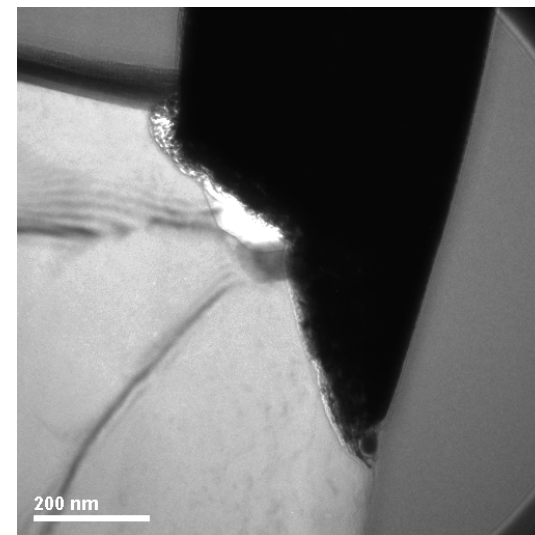
- ▶ VIA Alignment error
- ▶ Caused via to form poor contact
- ▶ Void and oxidation at interface
